Appendix B: Forms of Flat Land Damage

Figures B1.2 to B1.3: Photos of land with none-to-minor liquefaction related land damage.

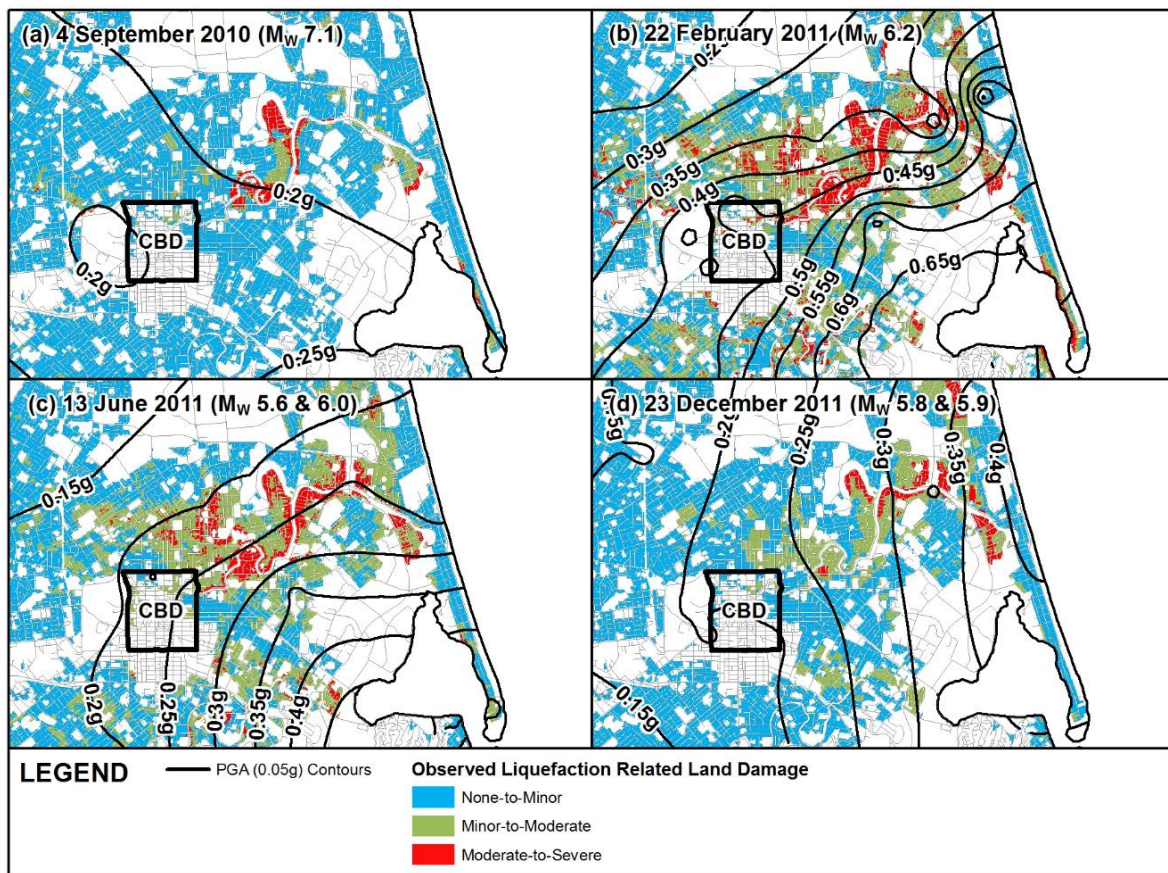
Figure B1.1: Map showing the inferred levels of earthquake shaking and the observed land damage for urban residential properties in Christchurch after the (a) 4 September 2010, (b) 22 February 2011, (c) 13 June 2011 and (d) 23 December 2011 earthquakes

In Figure B1.1 the contour lines for the June 2011 and December 2011 are the estimated PGA contour lines for the main earthquake events on those dates. These do not capture the influence of the PGAs associated with the foreshocks of these events which are relevant to the liquefaction related damage observed. This is discussed in more detail in Section 3.7.3 of the report.

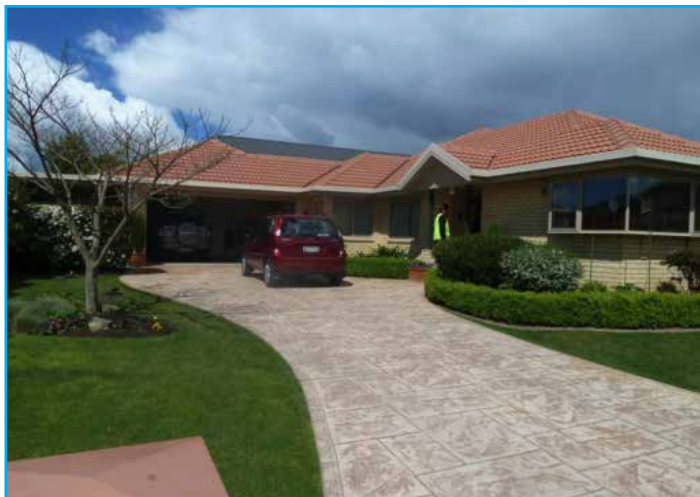
Even lawns and undamaged pavers

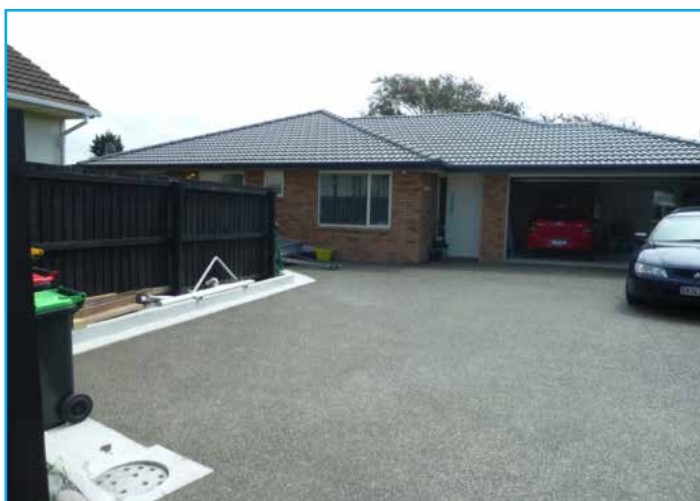
Undamaged concrete driveway and kerbing

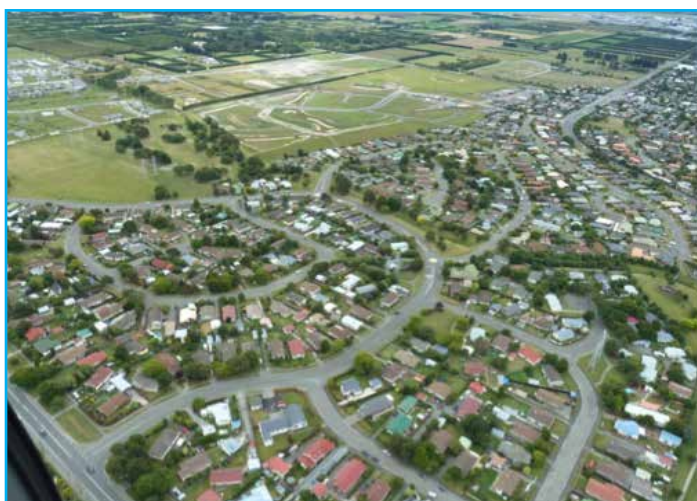
Aerial shot of Broomfield area showing no liquefaction ejecta on the roads or Broomfield Common

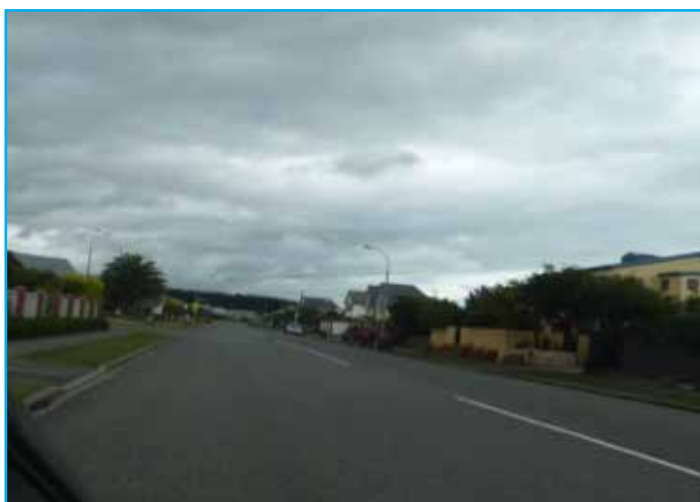
View of Aston Drive with little damages

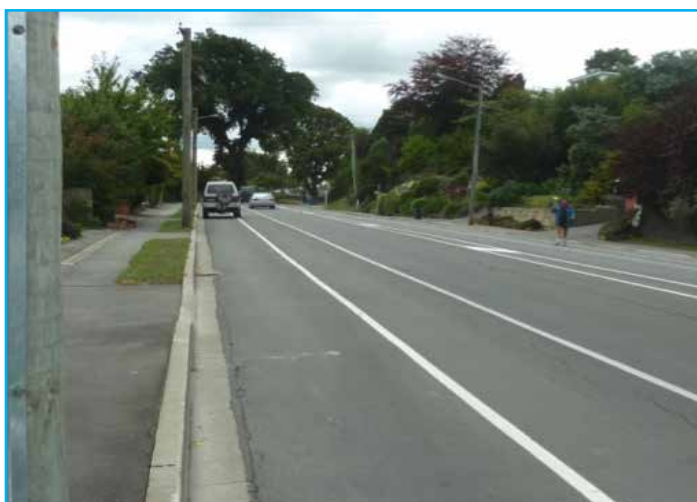
View of Centaurus Road with little damage

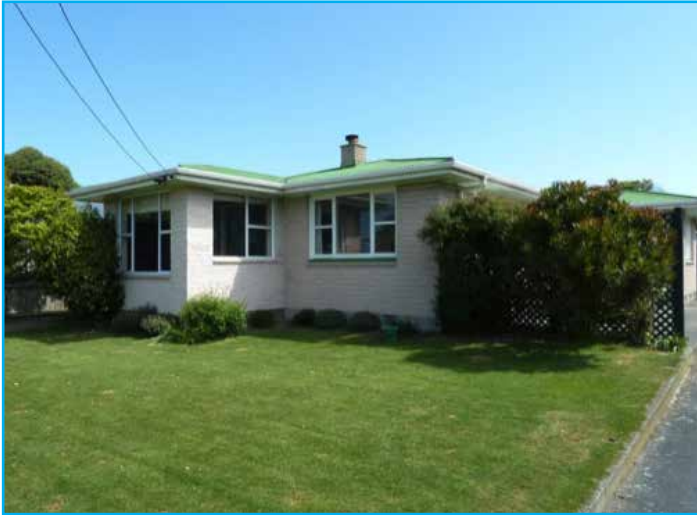
Flat lawn

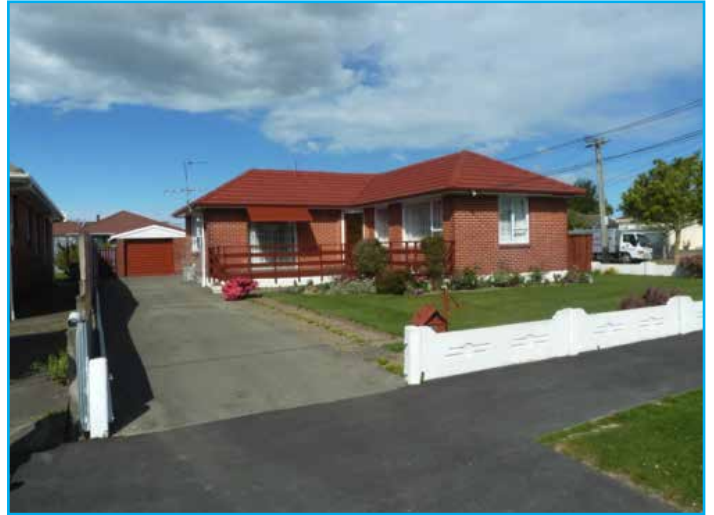
Slightly undulating lawn and driveway

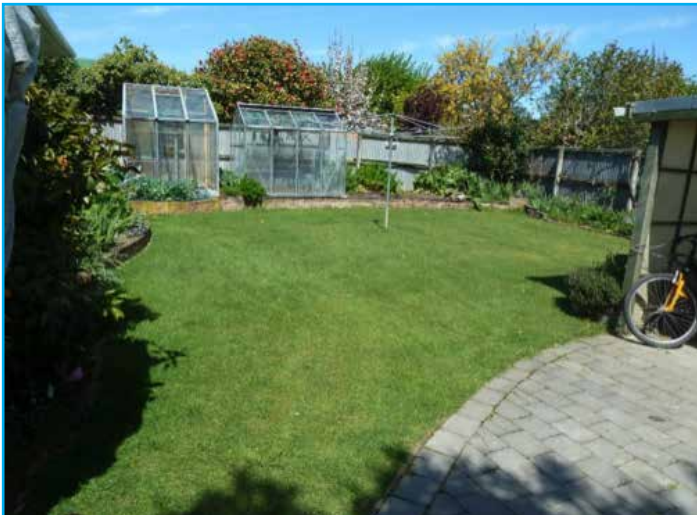
Slightly undulating lawn

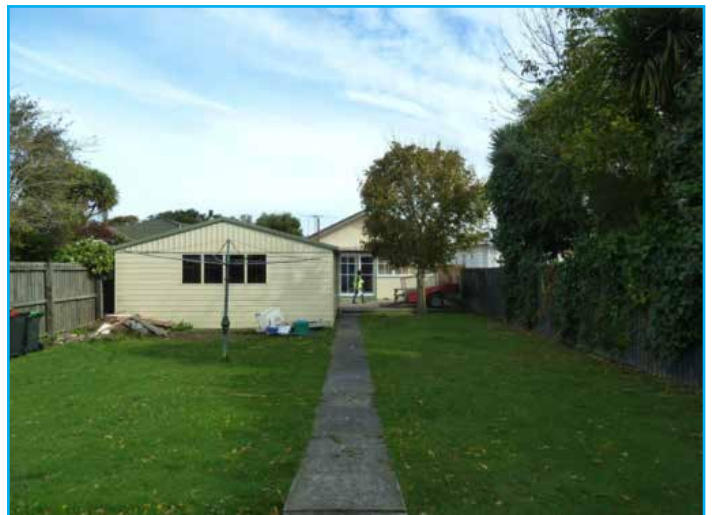
Undulating lawn

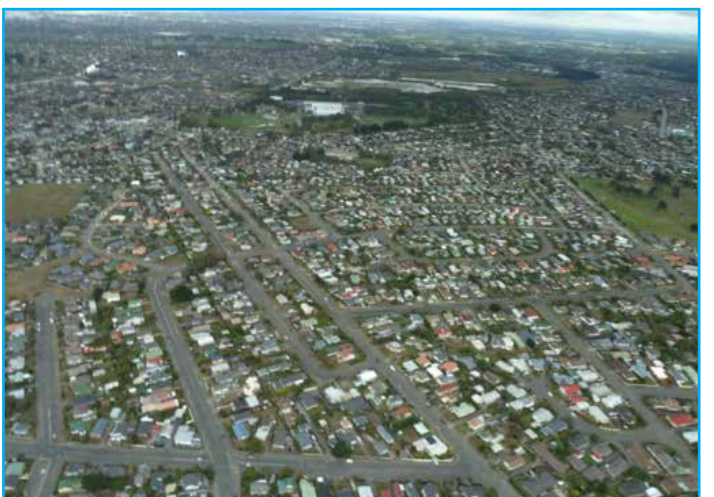
Aerial photo of North New Brighton showing little damage

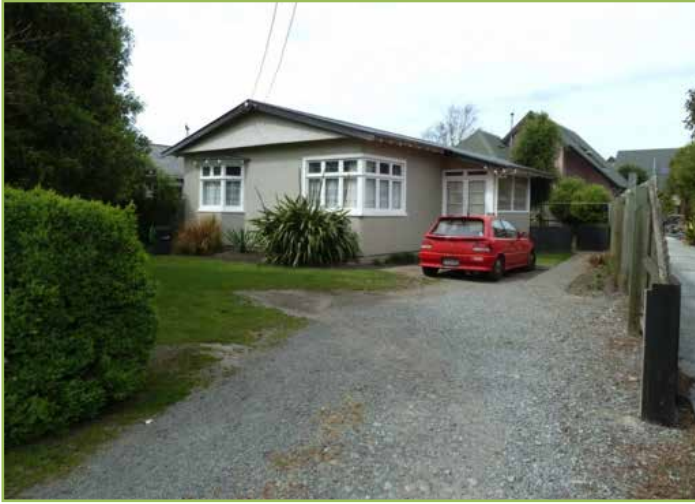
Undulating lawns and liquefaction ejecta

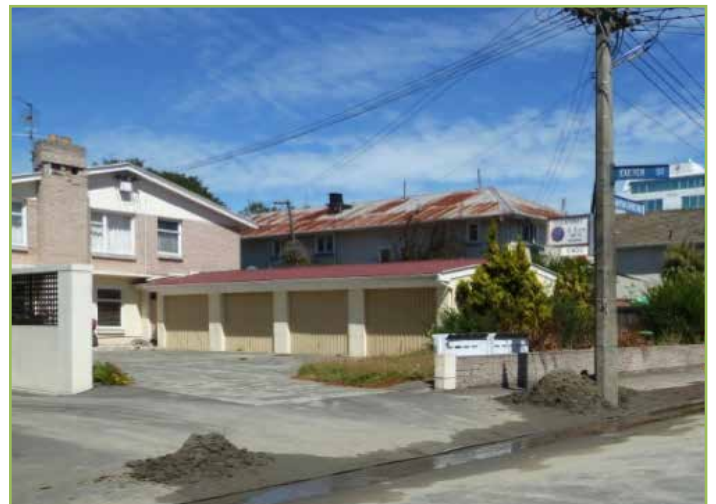
Piles of sand along the footpath

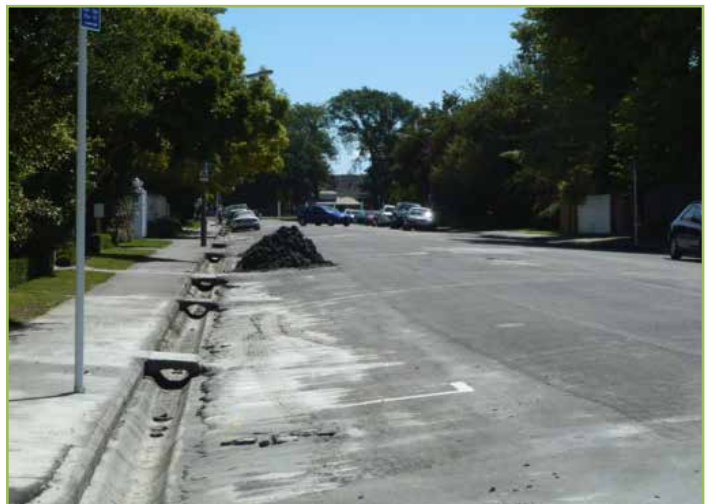
Liquefaction ejecta pile on road

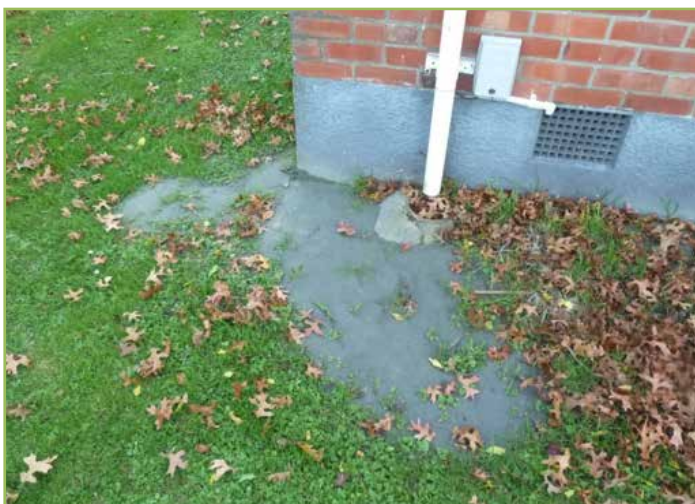
Isolated area of liquefaction ejecta on lawn

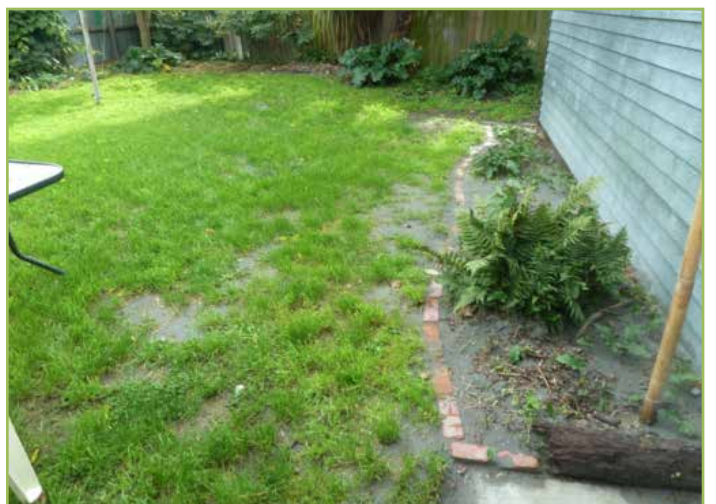
Isolated area of liquefaction ejecta on lawn

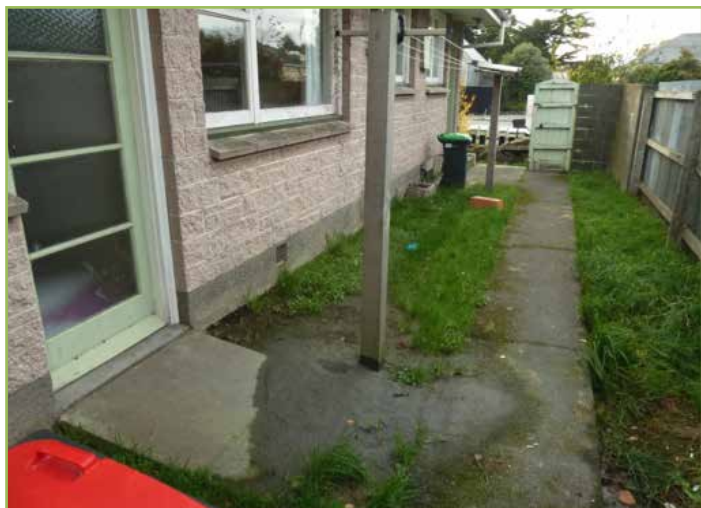
Liquefaction ejecta around washing line pole

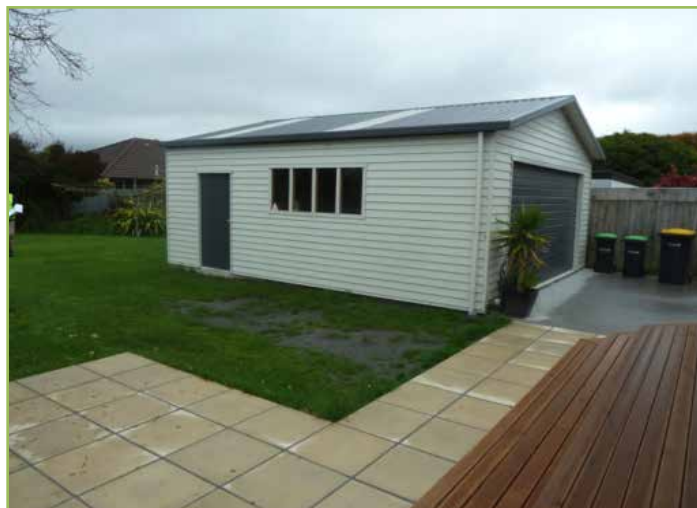
Liquefaction ejecta on lawn

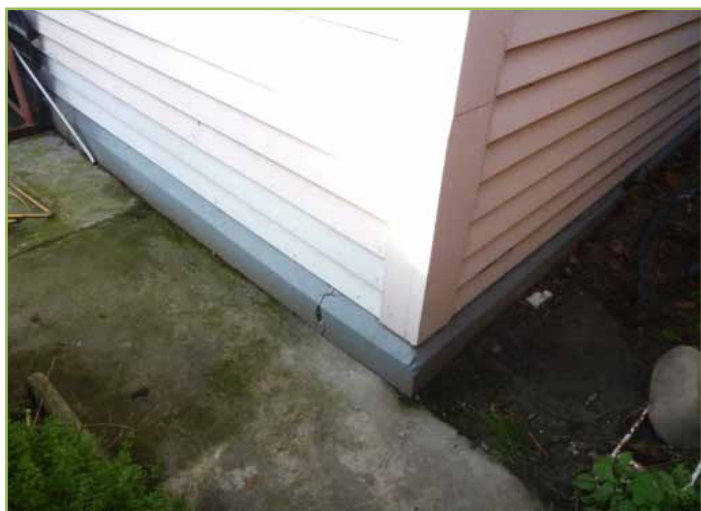
Foundation damage

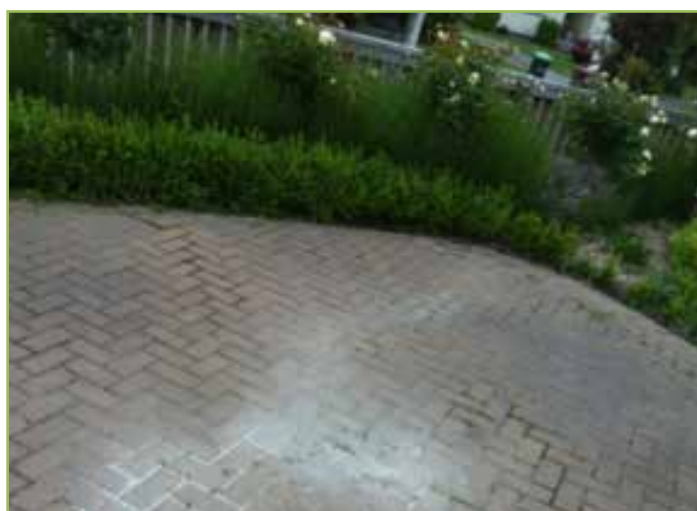
Undulating paving slabs

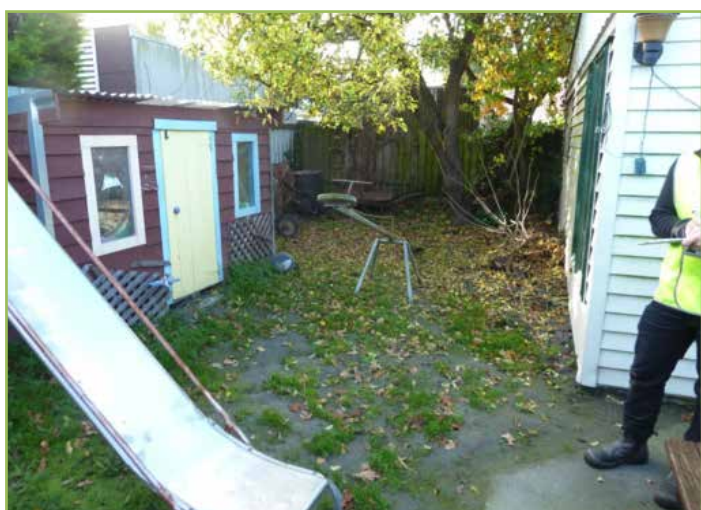
Liquefaction ejecta on lawn

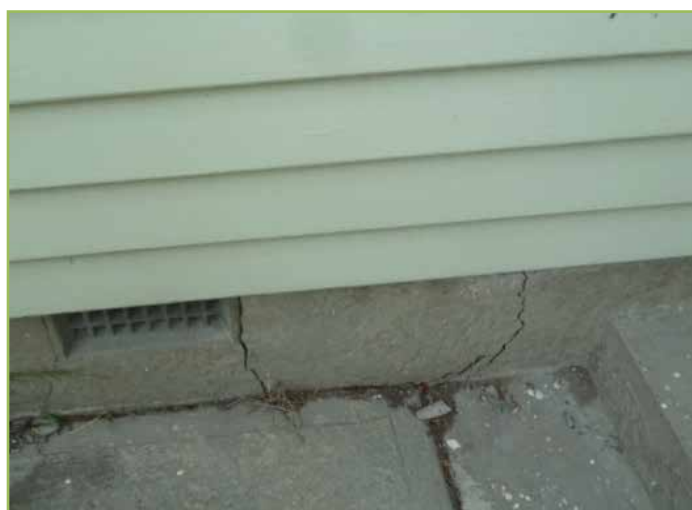
Foundation damage

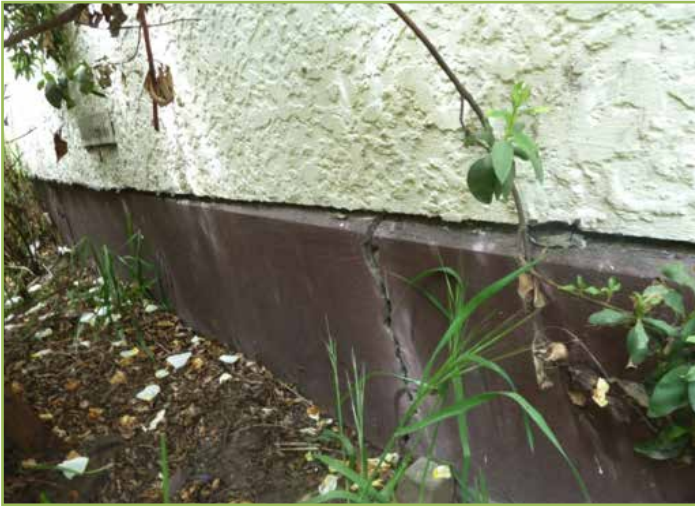
Foundation damage

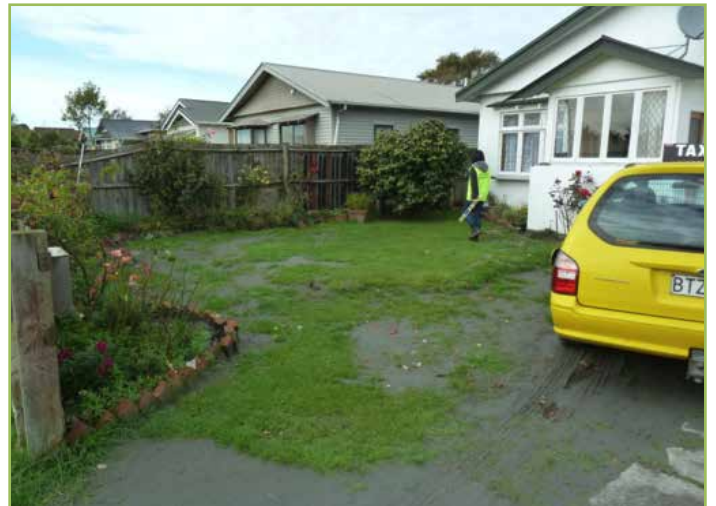
Liquefaction ejecta on lawn

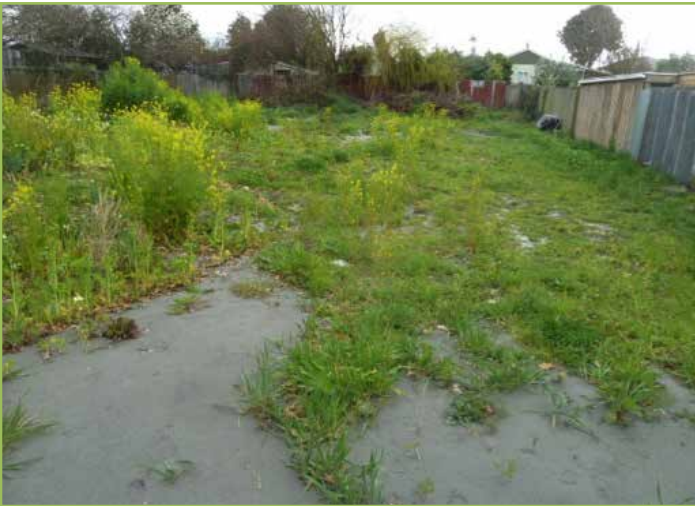
Liquefaction ejecta on lawn

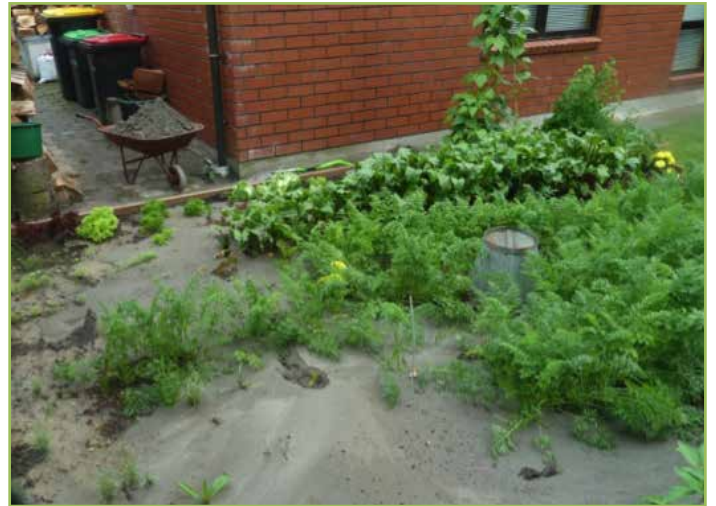
Liquefaction ejecta in planter

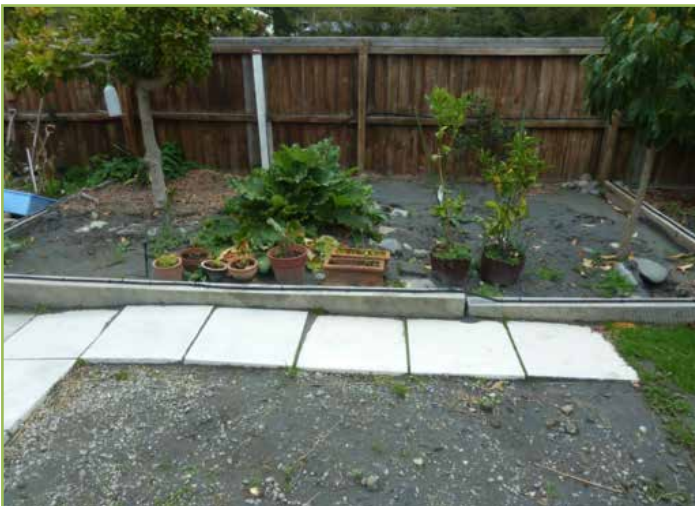
Liquefaction ejecta in planter with undulating pavers

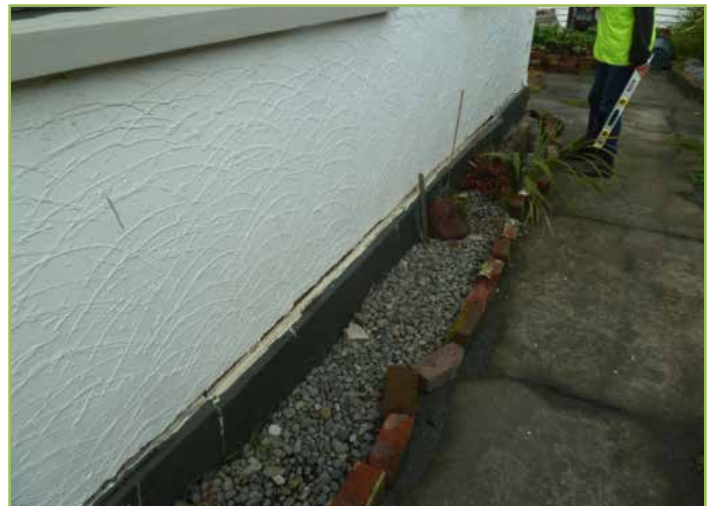
Foundation damage

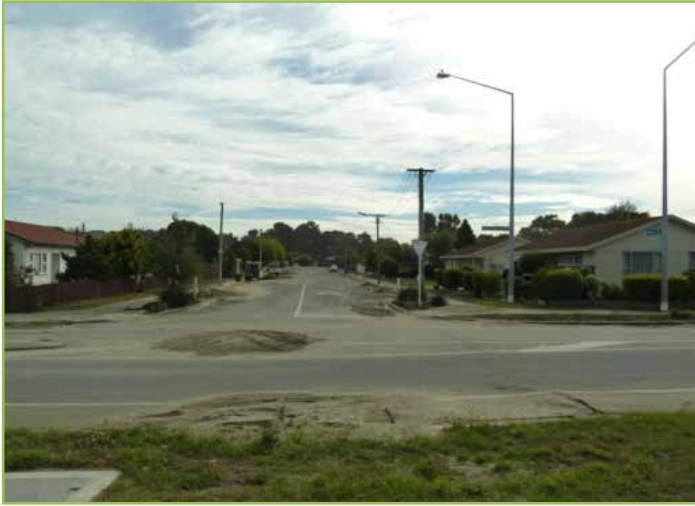
Liquefaction ejecta at a New Brighton Road junction

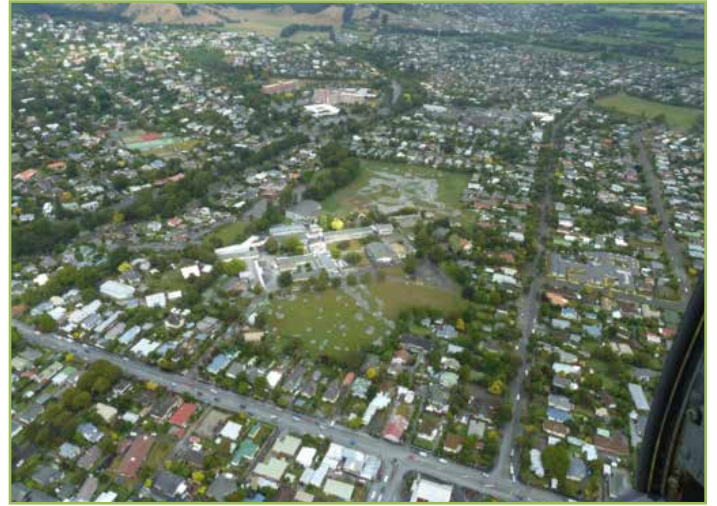
Aerial photo of liquefaction ejecta at Cashmere High School

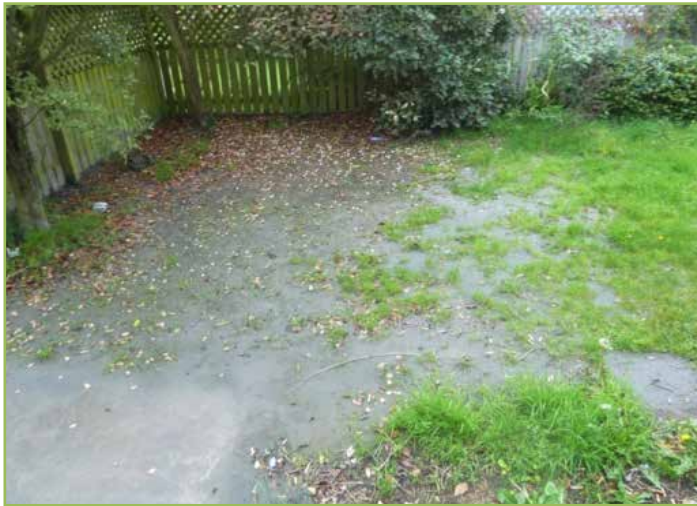
Liquefaction ejecta on lawn

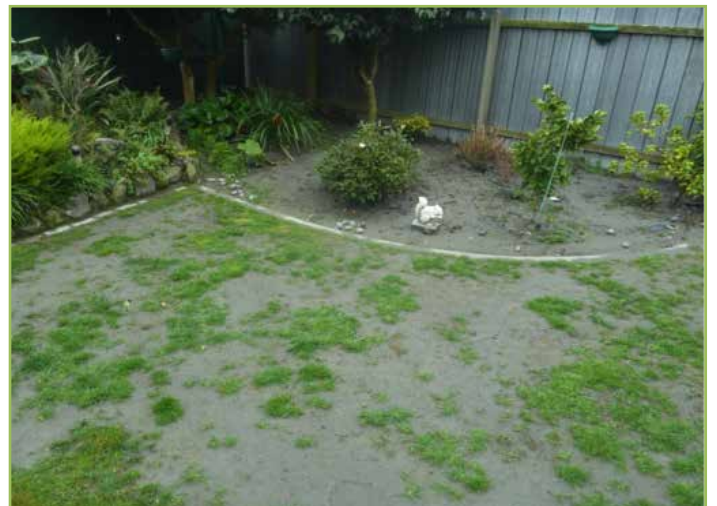
Liquefaction ejecta on lawn

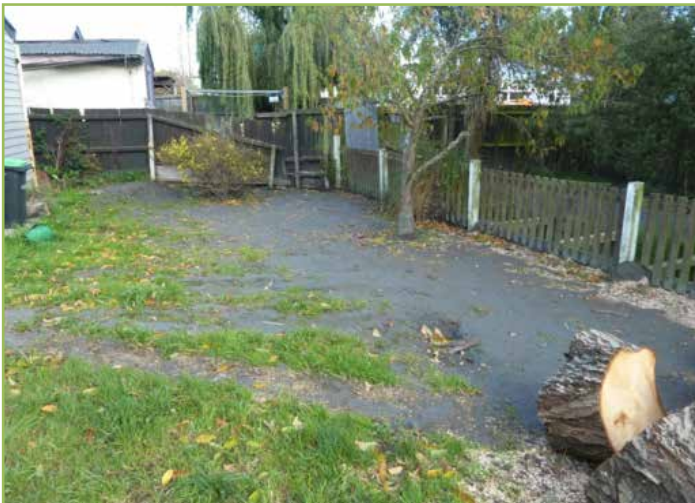
Liquefaction ejecta on lawn

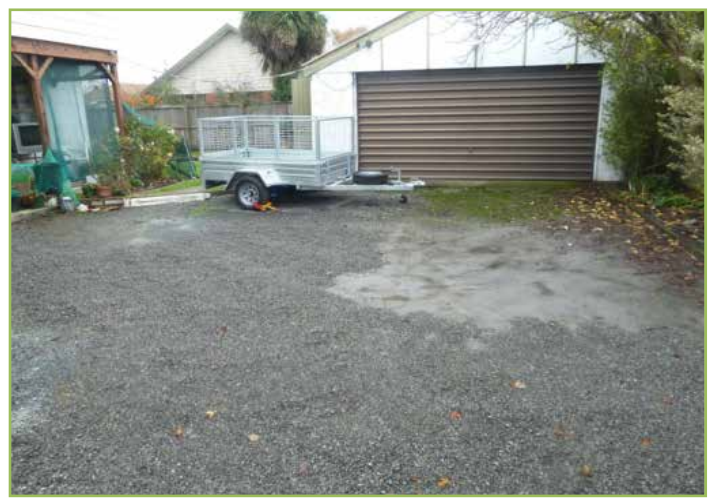
Isolated area of liquefaction ejecta

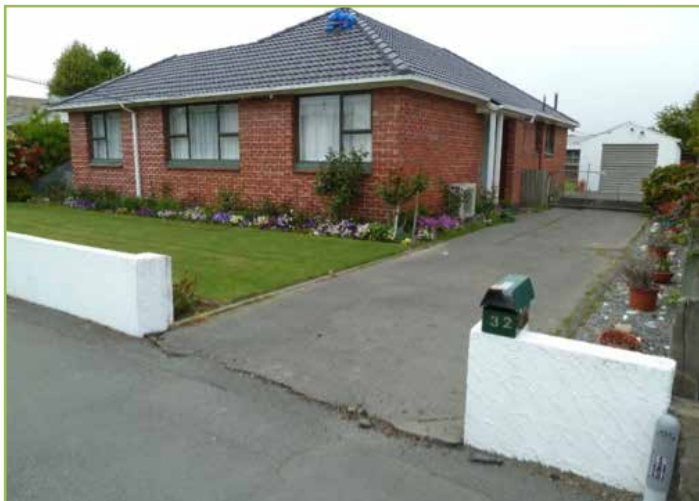
Damage to asphalt

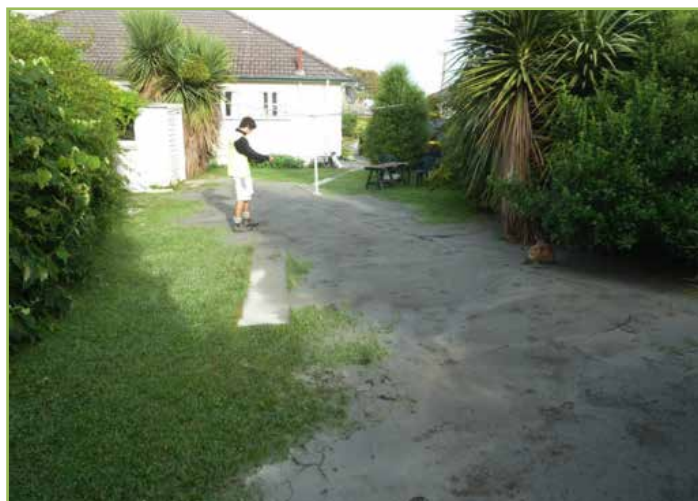
Liquefaction ejecta on lawn

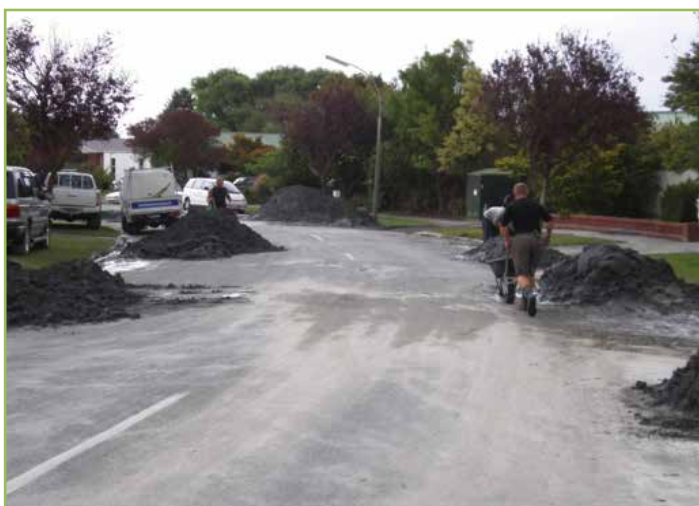
Liquefaction ejecta in piles on road

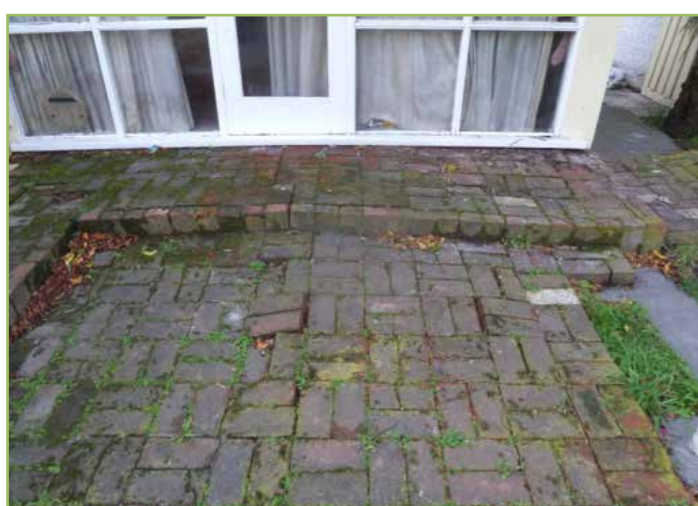
Undulating paving bricks

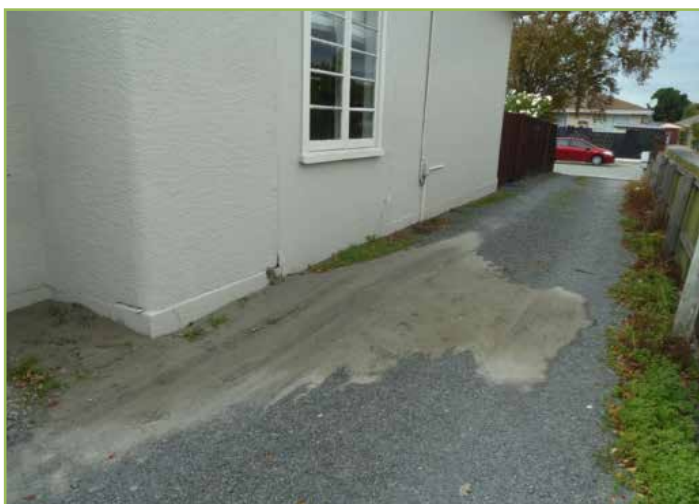
Isolated area of liquefaction ejecta

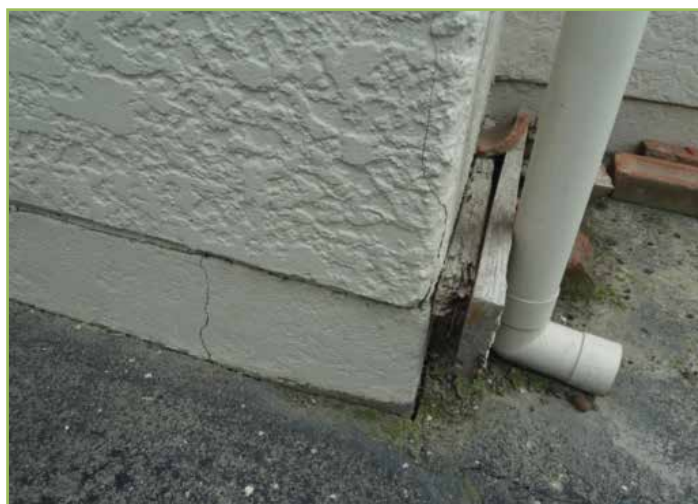
Foundation damage

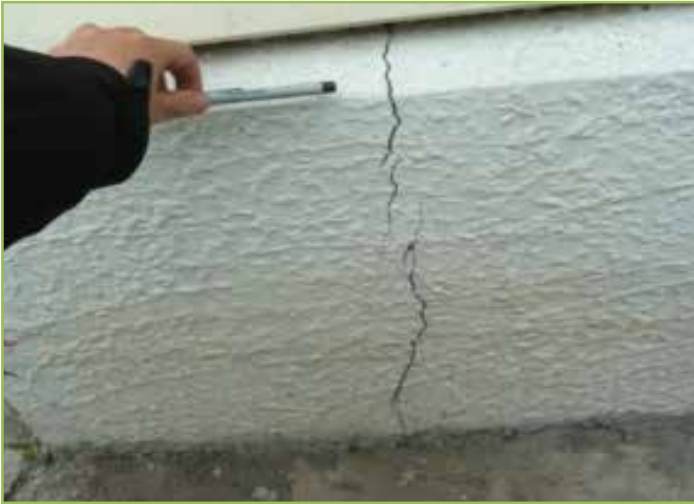
Foundation damage

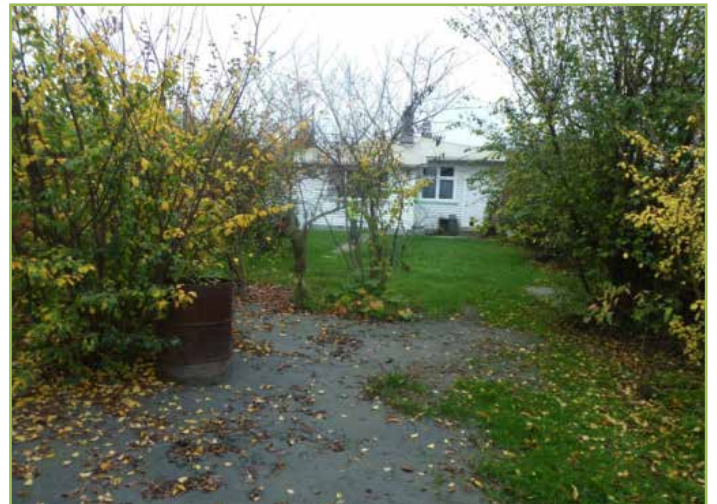
Liquefaction ejecta on lawn

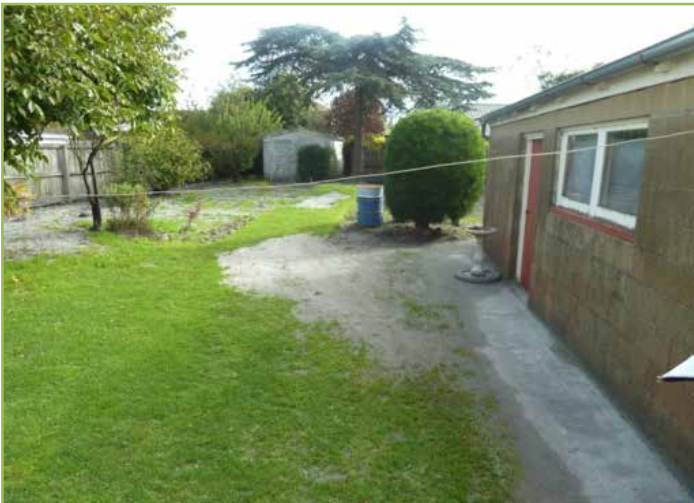
Liquefaction ejecta in many places on lawn

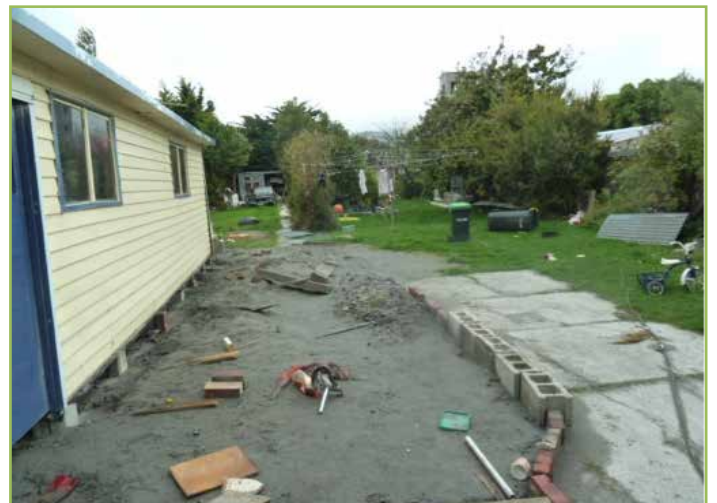
Large area of liquefaction ejecta on lawn

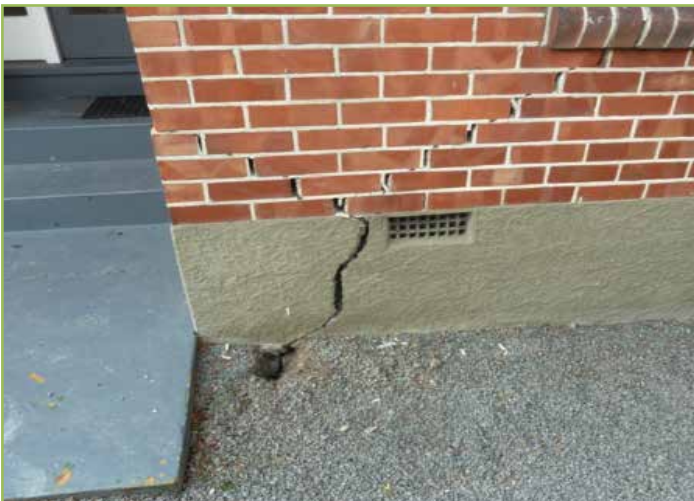
Foundation and brickwork damage

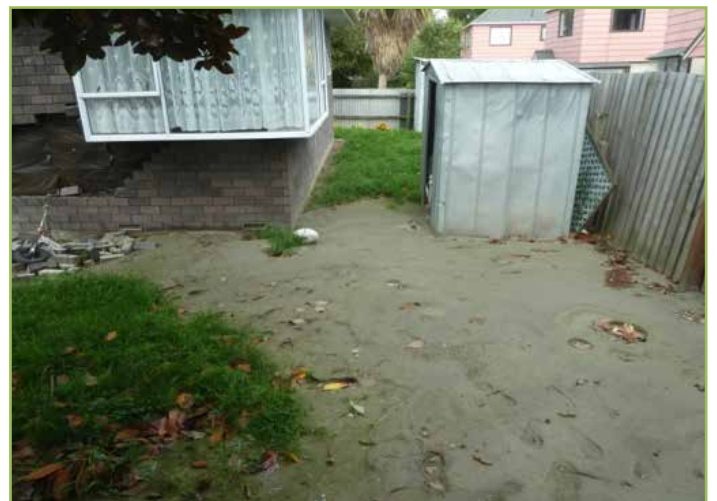
Liquefaction ejecta and brickwork damage

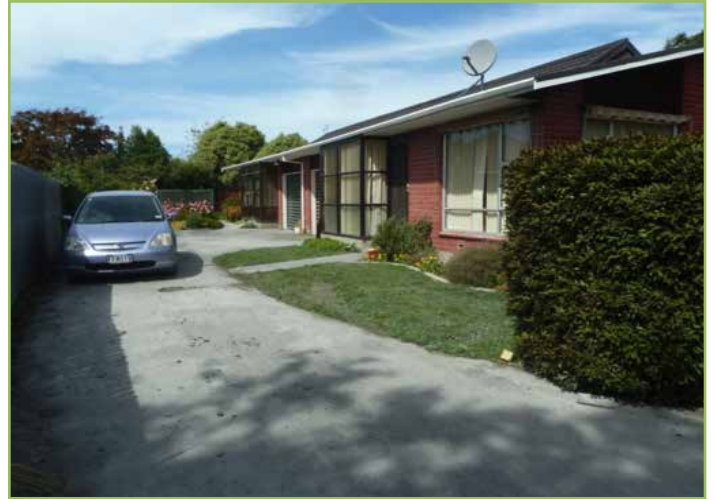
Undulations in lawn

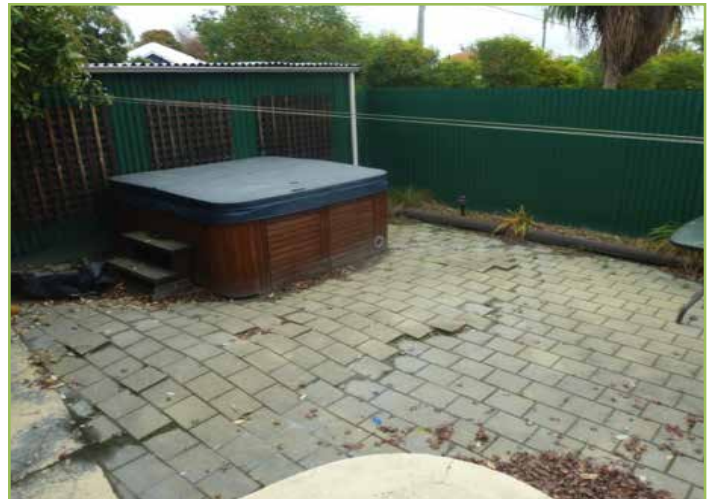
Undulations in paving area

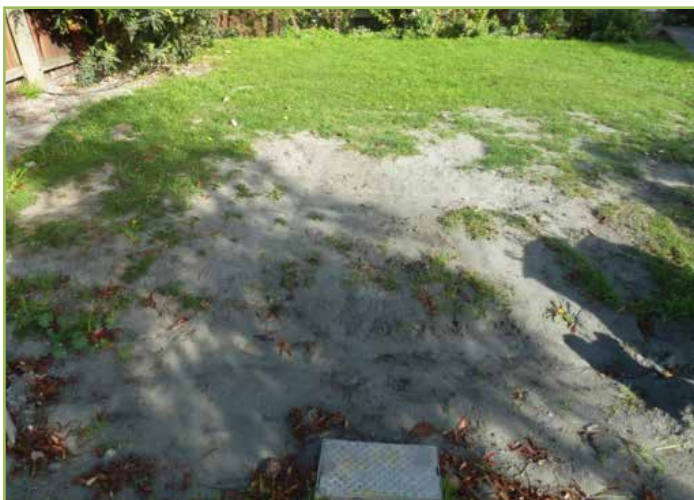
Liquefaction ejecta on lawn

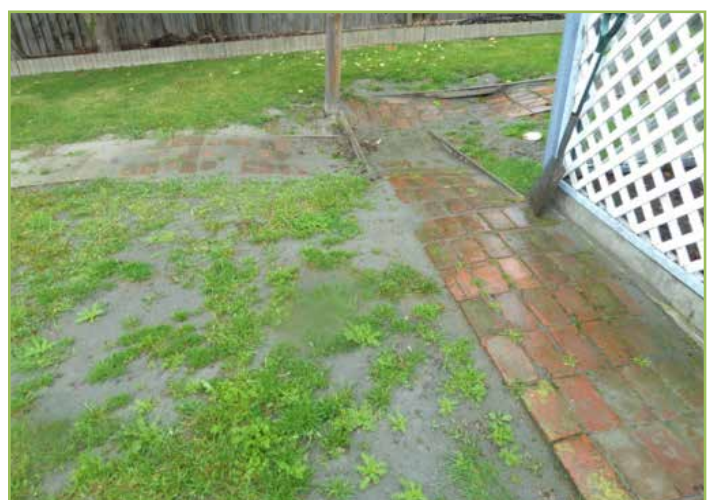
Undulations in lawn, liquefaction ejecta removed

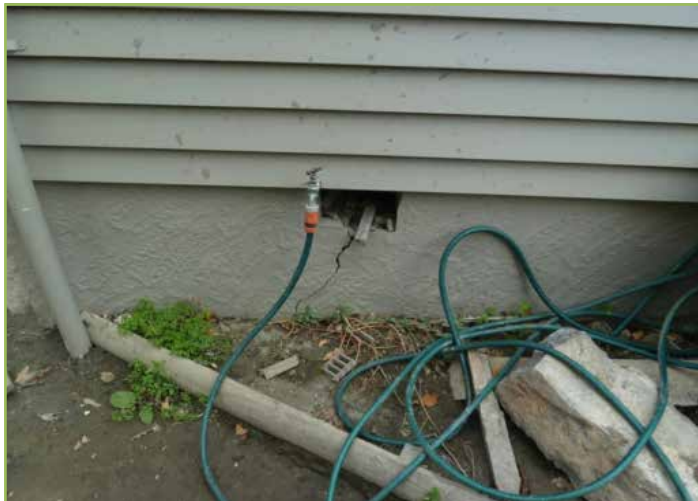
Foundation damage

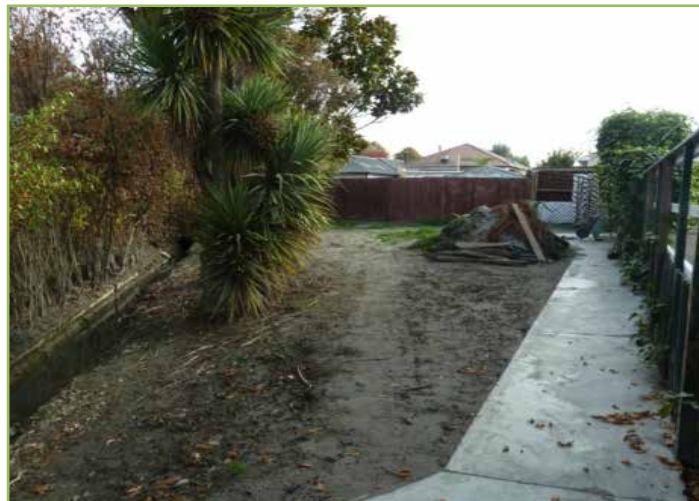
Liquefaction ejecta alongside culvert

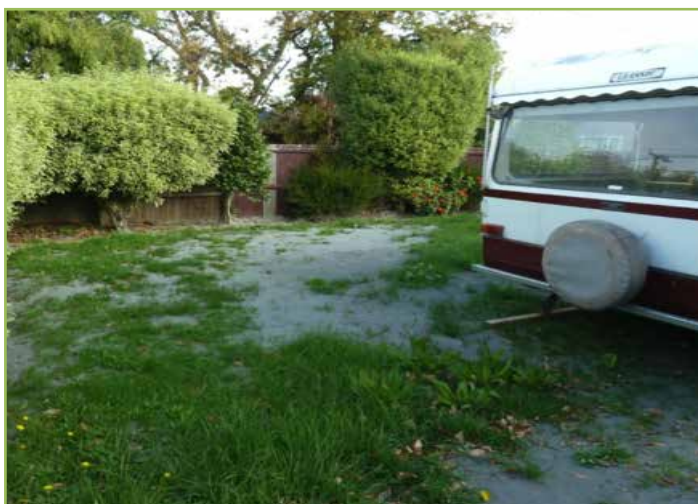
Liquefaction ejecta on lawn

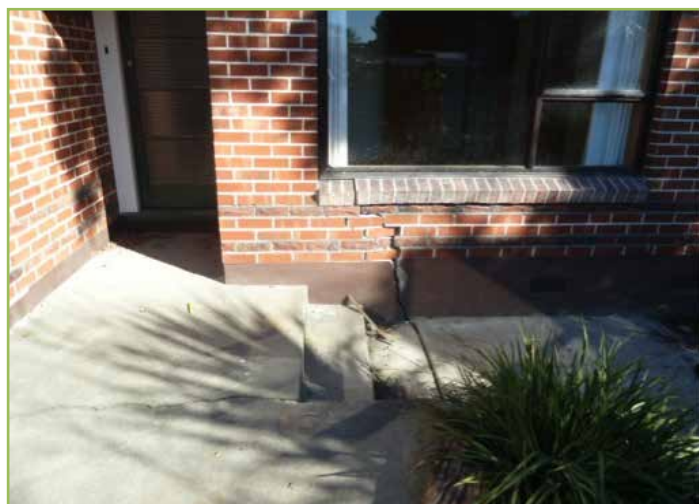
Foundation damage

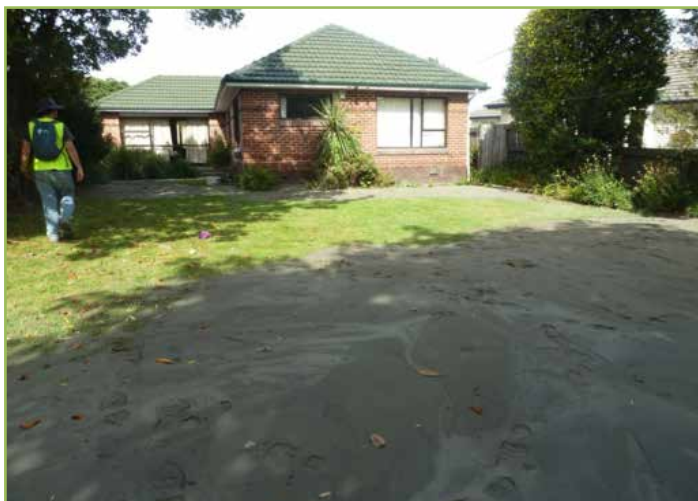
Liquefaction ejecta, dwelling tilting

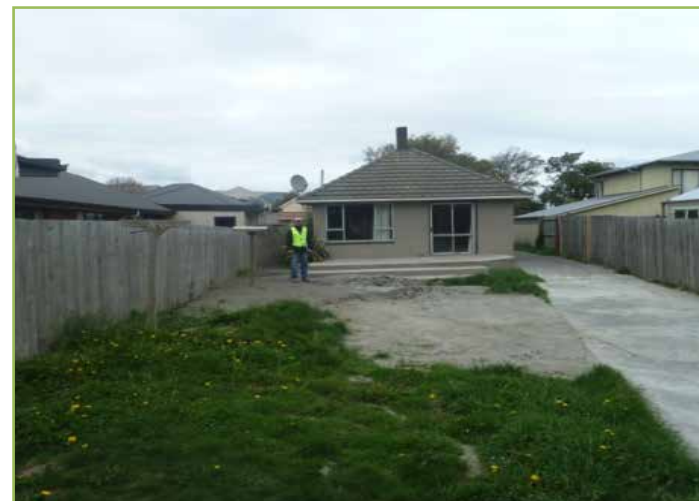
Liquefaction ejecta, dwelling tilting

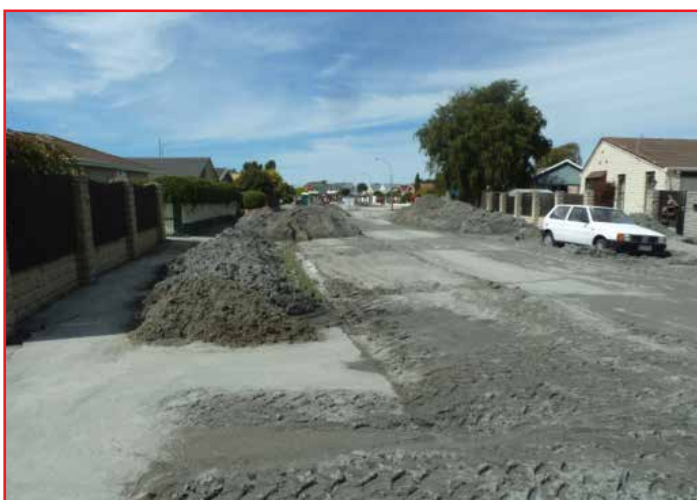
Liquefaction ejecta piles along Androssan Street

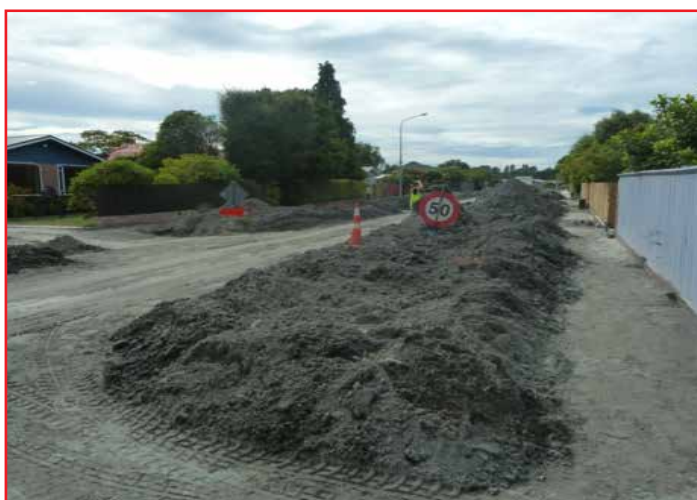
Liquefaction ejecta piles along Avonside Drive

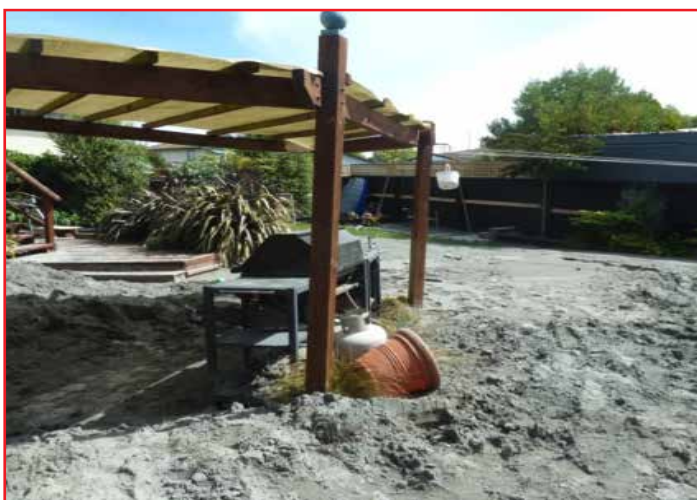
Liquefaction ejecta around property

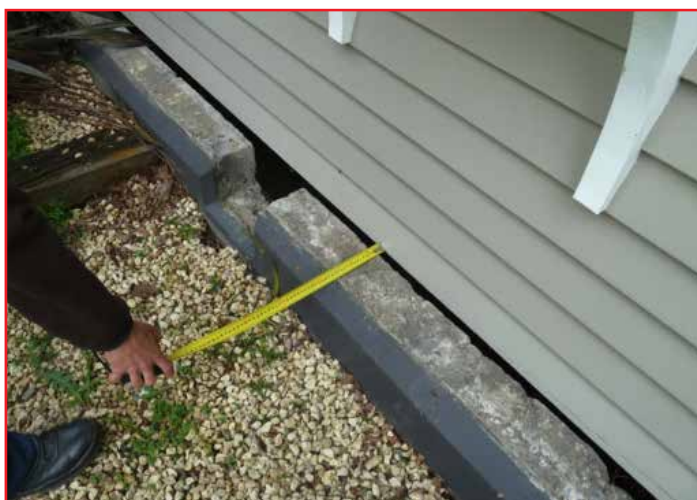
Foundation damage

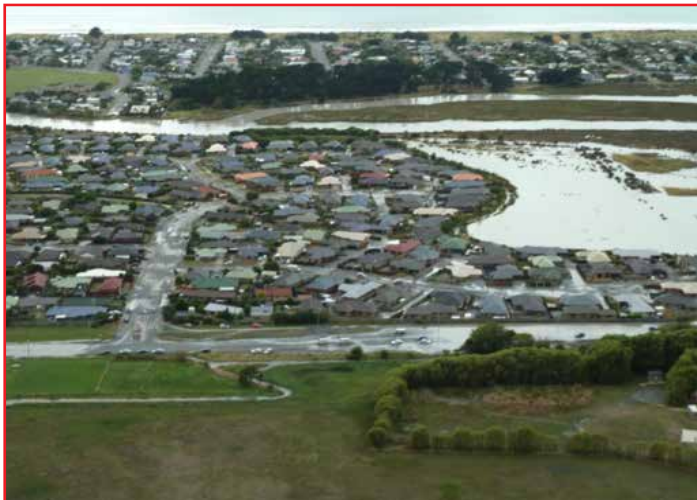
Aerial photo showing liquefaction ejecta on Seabreeze Close
