Appendix B: Forms of Flat Land Damage

Figures B1.2 to B1.3: Photos of land with none-to-minor liquefaction related land damage.

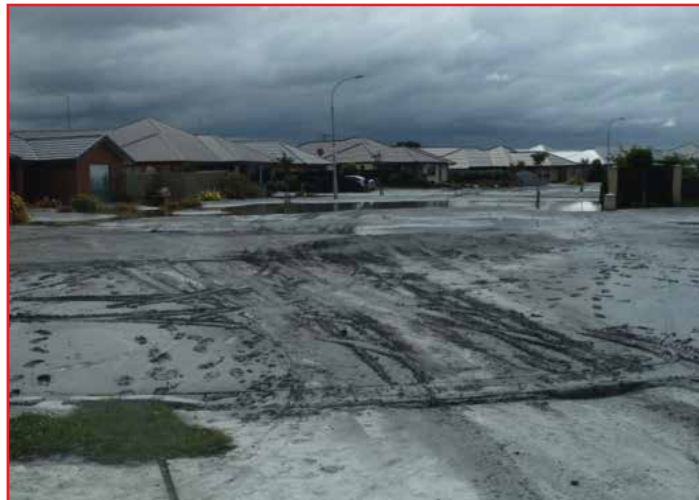
Liquefaction ejecta in turning circle of Seabreeze Close

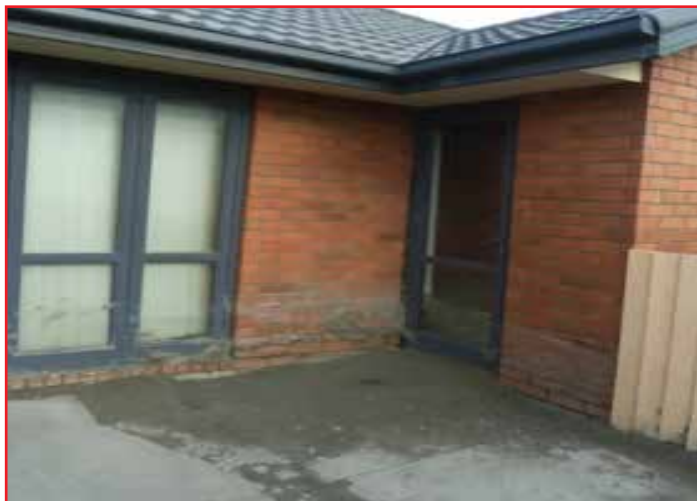
Outside of dwelling showing level liquefaction ejecta reached on brickwork and windows

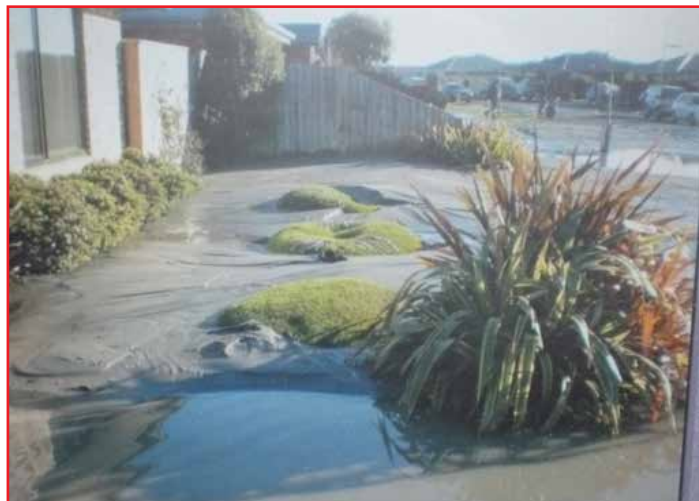
Large amounts of liquefaction ejecta

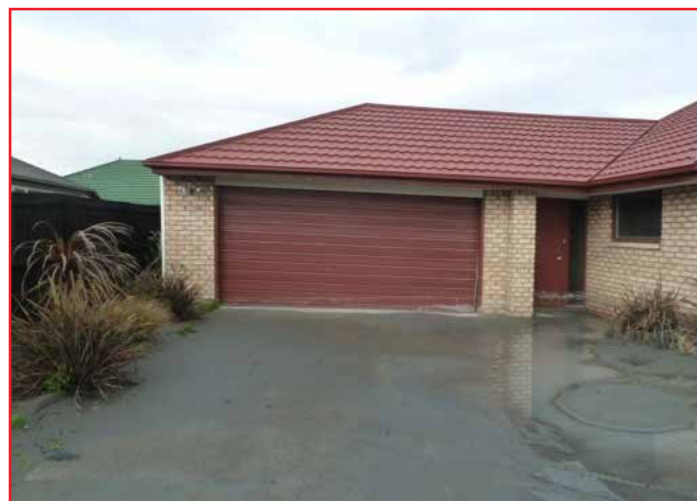
Large amounts of liquefaction ejecta and tilting dwelling

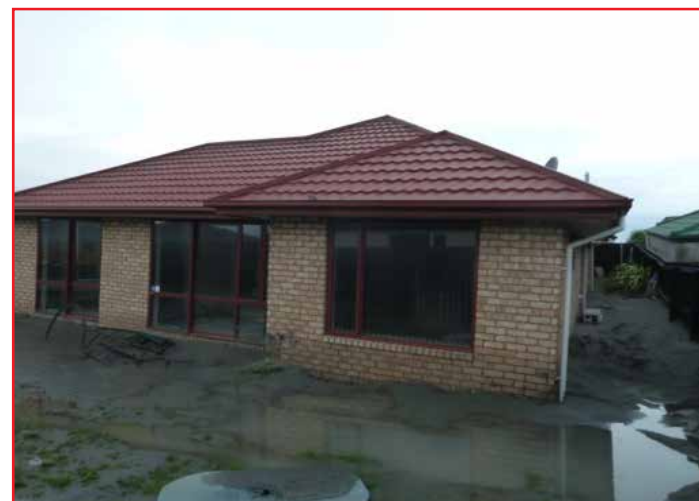
Large amounts of liquefaction ejecta around property

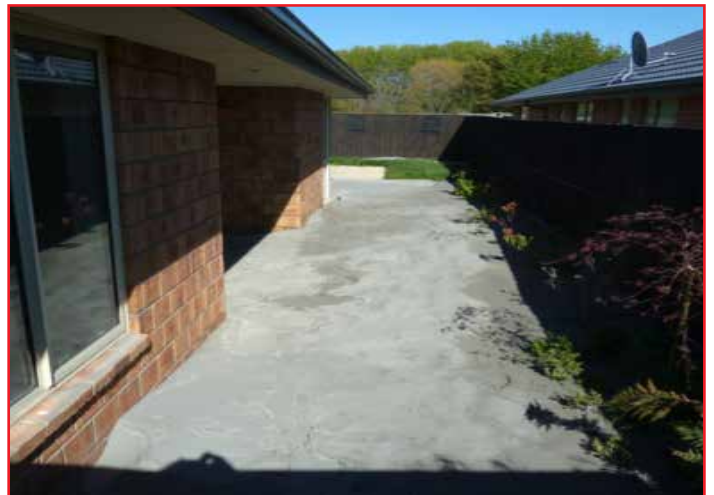
Large amounts of liquefaction ejecta

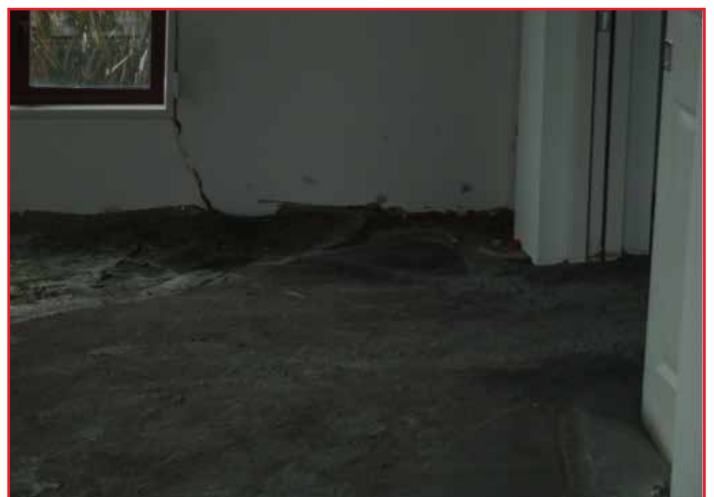
Large amounts of liquefaction ejecta inside dwelling

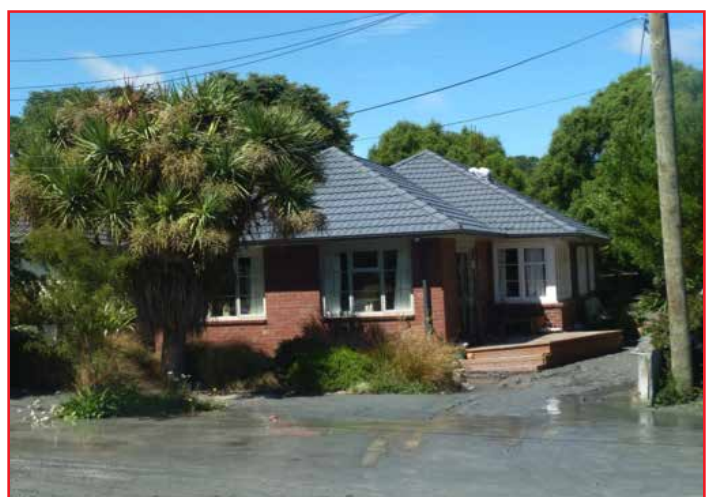
s) Foundation damage, tilting dwelling
