Title of Research (EQC grant reference number)

Retrofit Testing of Hollowcore Floors # 18/U769

Prof. Ken Elwood – University of Auckland (contract holder), Des Bull – Holmes Consulting

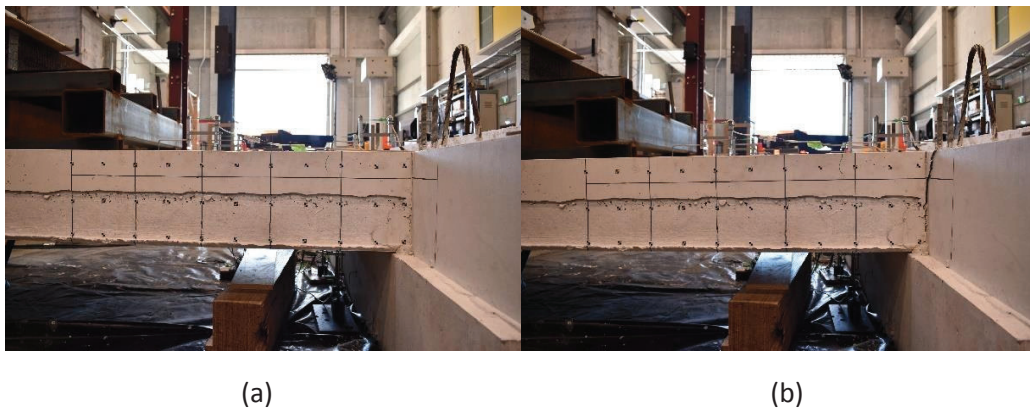
For the first component of the test, the unit was displaced with negative rotation until it reached a drift of -2.75%. The seating connection displayed the expected mechanism of a crack opening at the back face of the unit throughout the rotation. This crack started as an existing hairline crack and widened as the drift increased. The top of the crack reached a width of 6 mm at -2.75% drift and the bottom of the crack remained hairline in width, because the unit was pushed against the beam front face at the bottom during the rotation. An approximately 45-degree triangular wedge of spalling occurred at the back face of the unit over the full width of the ledge (50 mm). The starter bars had clearly yielded at this displacement demand. A comparison of the seating connection before testing and at -2.75% drift is displayed in Figure 8.

Figure 8: Specimen 1 Before Test (Left) and at -2.75% Drift (Right)

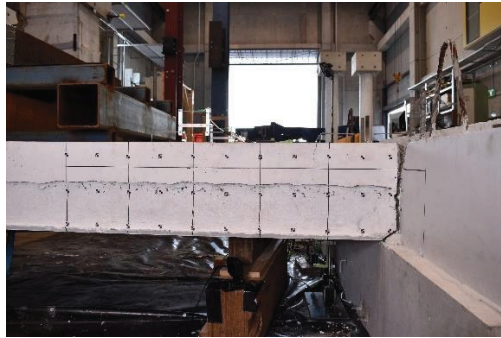
The cyclic displacement portion of the test followed the standard protocol previously described. No additional cracks were observed through this portion of the test. The only notable development was the widening of the residual crack as the level of applied displacement was increased through the drift cycles. At the end of the cyclic protocol, the crack at the back face of the unit had a residual width of 6.5 mm for the full depth. The unit was still well seated and displayed no indication of an unfavourable mechanism such as NMF, as shown in Figure 9.

Figure 9: Specimen 1 Residual Crack after Full Cyclic Protocol Up to $\pm 4.5\%$ Drift

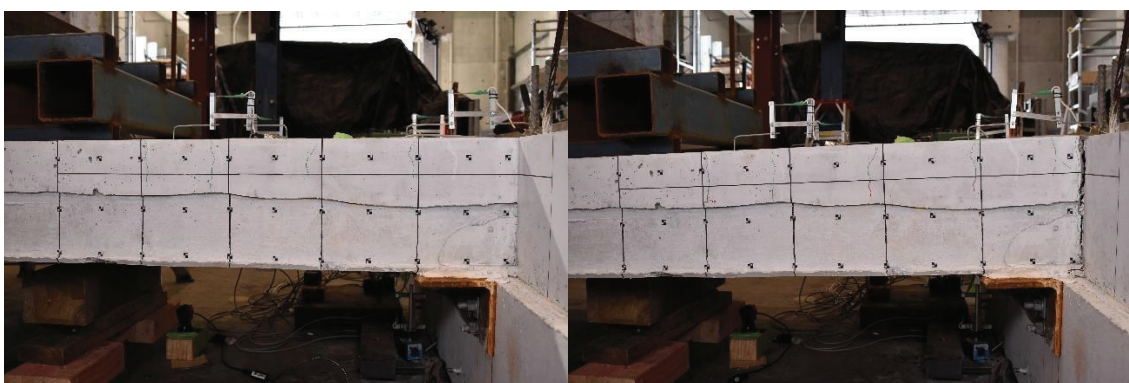
The unit was displaced to -2.75% drift for the monotonic push down component of this test. Like Test 1, a crack formed at the back face of the hollowcore unit and progressively widened at the top as the displacement demand was increased. None of the distributed shrinkage cracks propagated out of the topping concrete and in to the unit due to the imposed loads. An unexpected result from this test was that the angle displayed more flexibility than accounted for. This meant that instead of the assumed rigid connection providing full restraint to the hollowcore unit, the angle only provided partial restraint - and a lower than expected reaction at the end of the angle. This reduced reaction proved insufficient to trigger NMF. The bending of the angle under load imposed by negative rotation of the hollowcore unit can be seen in Figure 10.

Figure 10: Specimen 2 Before Testing (Left) and at -2.75% Drift (Right)

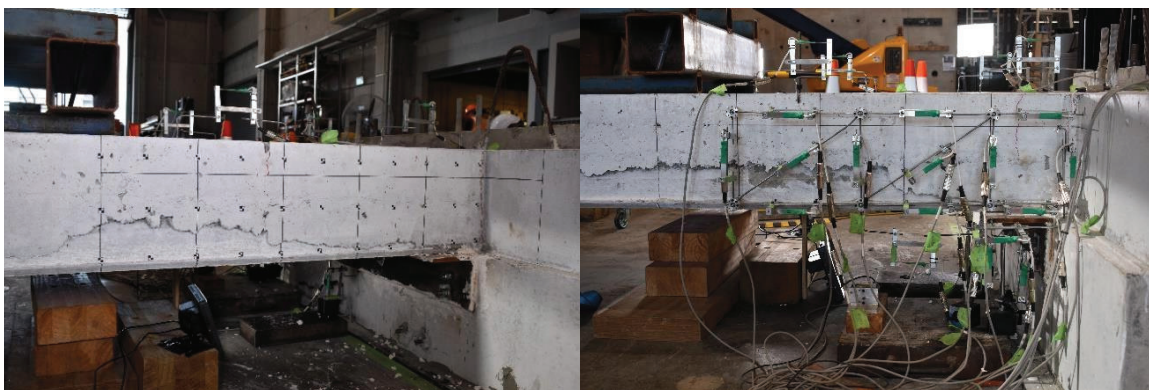
Until -0.5% drift, cracking was only observed at the back face of the unit, similar to the previous tests. Directly beyond -0.5% drift, the initiated crack at the end of the starter bars propagated down to the interface between the topping and unit on the west side. On the east side, the initiated crack propagated only part way into the topping. A second crack also appeared on the east side at 140 mm from the back face that extended almost half-way into the unit as shown in Figure 112.

Figure 112: Specimen 3 at -0.53% Drift – Initial Crack Propagation (West – Left, East – Right)

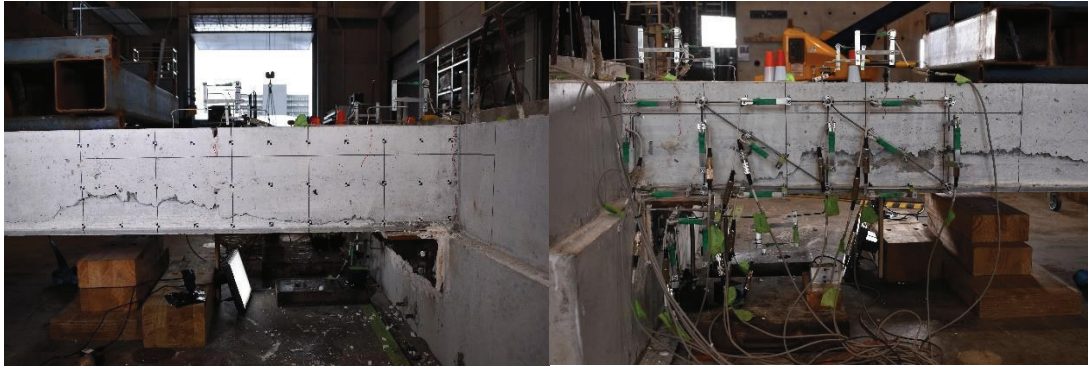
At -0.75% drift, a crack at 230 mm from the back face of the unit propagated into the unit approximately 25 mm on the west side. The low stiffness of the connection because of the angle flexibility appeared to cause more concentration of damage closer to the back face of the unit. The crack at the saw cut section split into two cracks on the west side but neither continued into the

unit. On the east side, the crack at the saw cut section propagated down 5-10 mm into the unit. The progression of cracking at -0.75% drift is displayed in Figure 13.

Figure 13: Specimen 3 at -0.75% Drift (West – Left, East – Right)

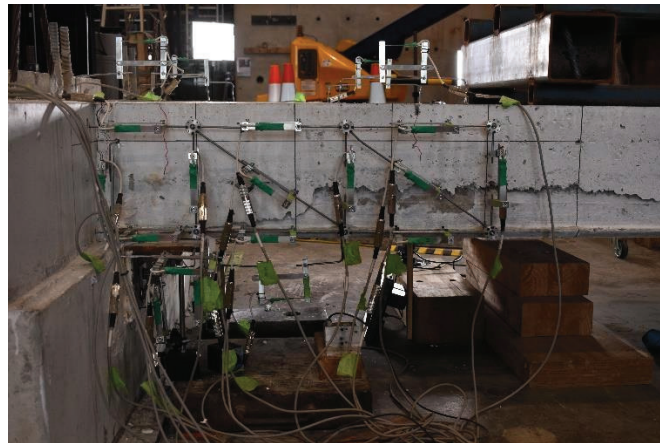
At -1.25% drift, the crack at the saw cut section on the east side propagated further to approximately 30 mm into the unit as shown in Figure 14.

Figure 14: Specimen 3 at -1.25% Drift – Critical Crack Propagation (East Side)

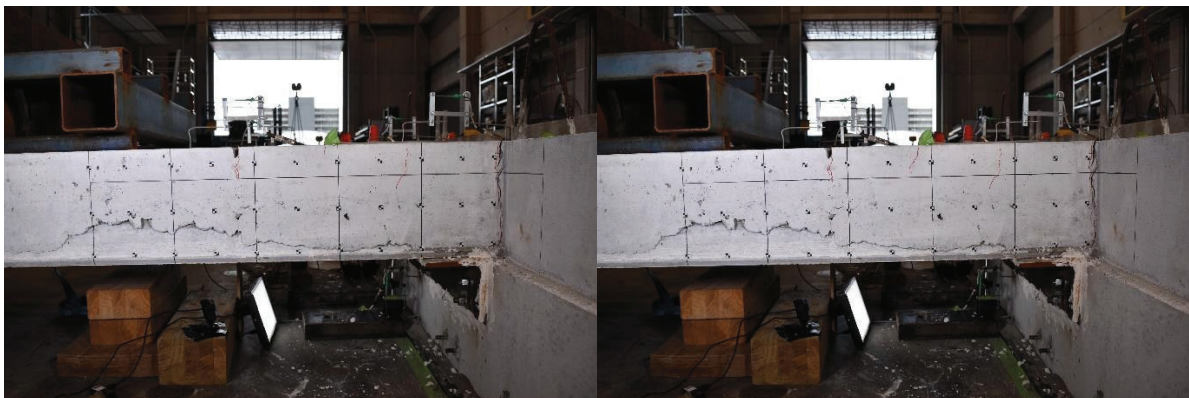
No additional unit cracking was observed until at -1.75% drift, when another negative moment crack began developing between the previous two cracks on the west side. It stopped developing beyond -2.0% drift and did not leave the topping. This crack can be seen in Figure 15.

Figure 15: Specimen 3 at -1.75% Drift (Left) and -2.0% Drift (Right) (West Side)

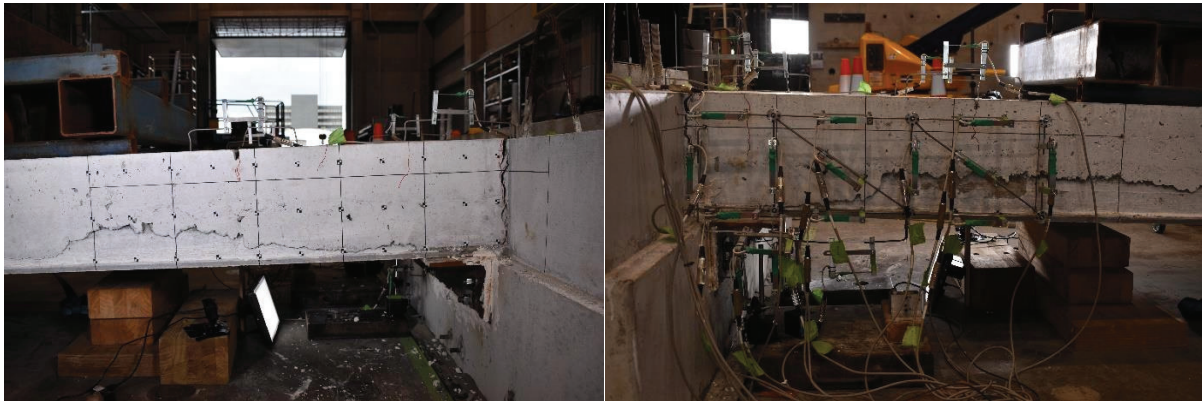
Beyond -2.0% drift, no additional damage was observed in the unit. All damage had concentrated at the back face of the unit. The test was therefore concluded after reaching -3.5% drift and then returning to 0% drift, as negative moment failure had been avoided with this connection detail. The specimen at -3.5% drift is displayed in Figure 16.

Figure 16: Specimen 3 at -3.5% Drift – All Damage Concentrated at Back Face (West – Left, East – Right)

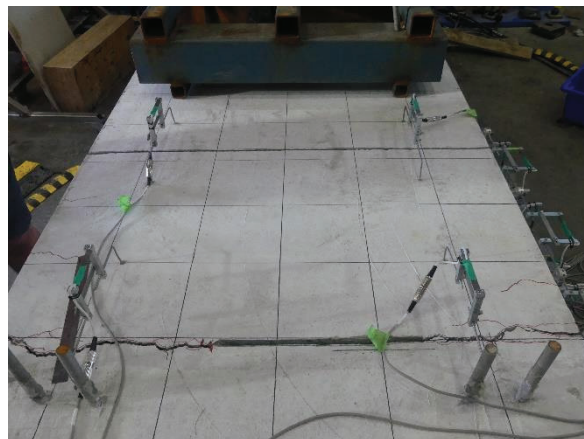
None of the cracking observed away from the back face of the unit developed across the full width of the topping as can be seen in Figure 17.

Figure 17: Top of the Specimen 3 at -3.5% Drift

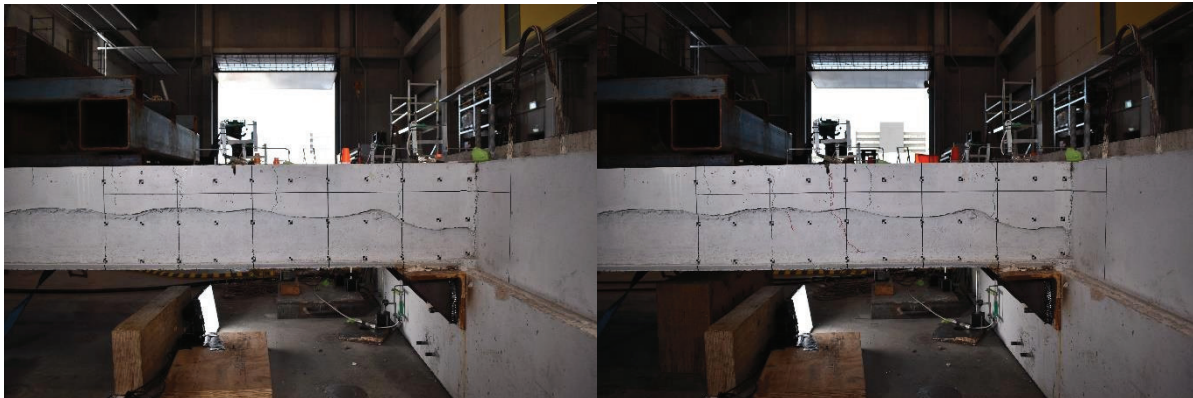
Initial cracking occurred at the back-face of the unit occurred at approximately -0.45% drift displacement. This caused an instant loss of stiffness and the unit dropped to -0.6% drift before picking up load again. Negative moment cracking occurred at -1.0% drift displacement. At this stage, the crack at the back face of the unit had opened to approximately 2 mm wide. The negative moment crack did not appear during loading, instead forming approximately 30 seconds after loading stopped. A loud cracking was heard and the unit lost stiffness, increasing the drift to -1.6%

instantaneously. The unit directly before and after the negative moment crack propagated is displayed in Figure 18 and Figure 19. This result was useful, because it showed that for negative moment cracking to occur, the crack at the back face of the unit needed to open first. The starter bars needed to be stressed and stretched across the back face of the unit to activate most of their strength. This created enough negative moment demand (tension at the top of the unit) at the end of the starter bars to crack the unit there. This hierarchy of failure mechanisms displayed that retrofit strategies aimed at pre-cracking the back face of the hollowcore unit would not sufficiently change the structural system to prevent NMF. After this point, loading was continued up to -1.75% drift where it was confirmed that all additional deformation was now occurring at the negative moment crack instead of the unit back-face crack.

Figure 18: West Side of Specimen 4 Directly Prior (Left, -1.0% Drift) and After (Right, -1.6% Drift) NM Crack Initiation

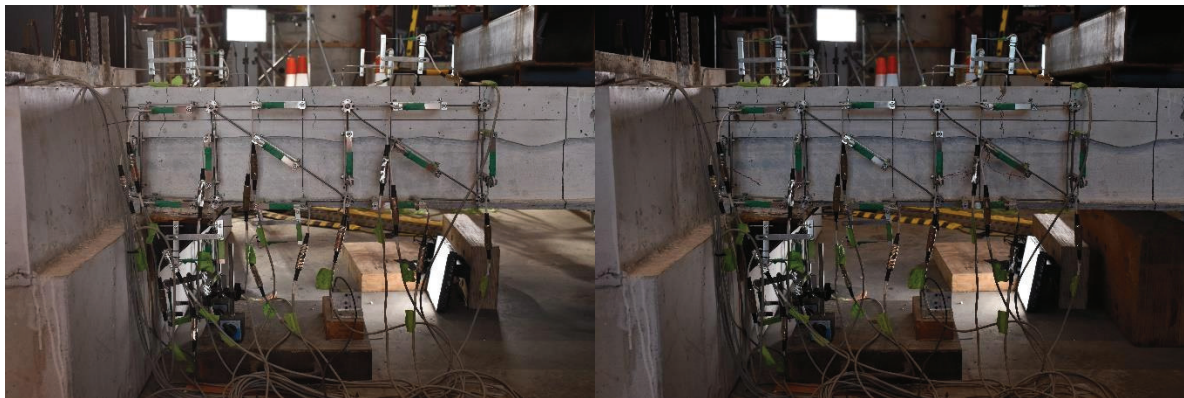
Figure 19: East Side of Specimen 4 Directly Prior (Left, -1.0% Drift) and After (Right, -1.6% Drift) NM Crack Initiation

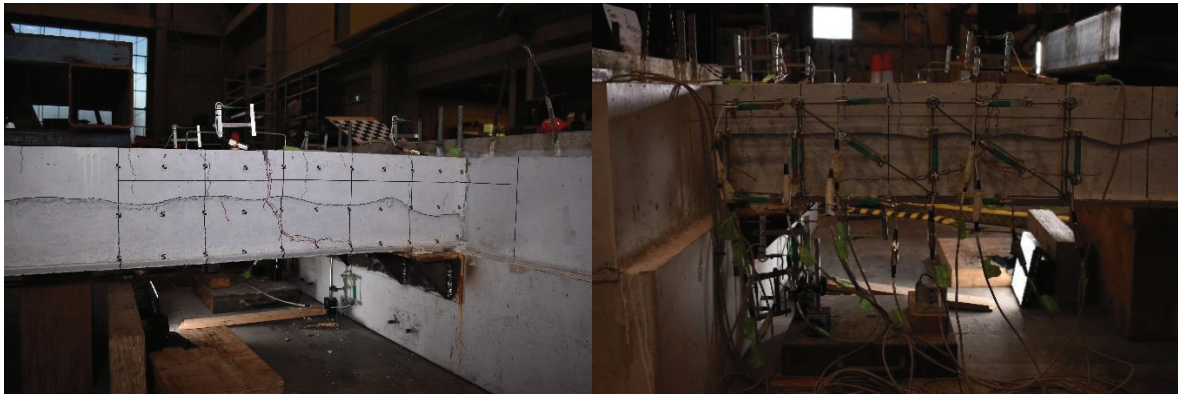
The specimen was returned to 0% displacement and a cyclic load protocol of was started. This consisted of 2 cycles at 1.0%, 2 cycles at 2.0% and a cycle up to 3.0% which the specimen failed at before reaching. An additional cycle of 5.0% was added at the end to display how the hollowcore unit was effectively a pin-roller connection depending only on the strength of the 7 prestress strands to keep it from falling. No significant additional damage was observed in the two 1.0% drift cycles. In the first 2.0% drift cycle, the crack had a sudden extension at -1.8% drift causing the unit to drop instantly to -2.15% drift which is displayed in Figure 20. At this stage the crack reached the depth of the prestress strands and propagated along them half way to the angle support. A vertical offset of

3 mm was observed at the top of the unit across the NMF crack (initiated by the saw cut). This vertical offset can be considered failure of the unit.

Figure 20: East Side (Left) and West Side of Specimen 4 (Right) at Second -2.0% Drift Peak Displacement Cycle

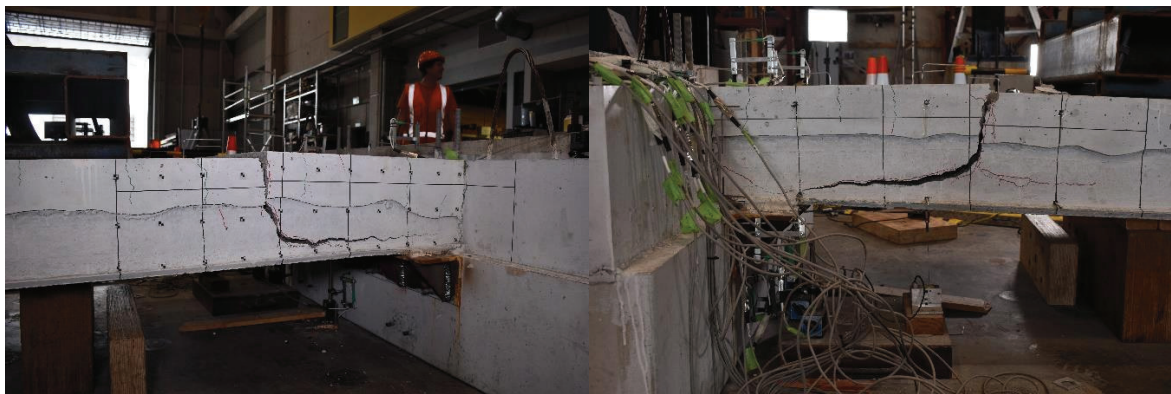
In the second 2.0% drift cycle, the unit had reduced stiffness in the negative portion of the displacement from the first cycle. The stiffness further decreased after a minor additional crack propagation occurred at approximately 1.15%. In the 3.0% drift cycle, the unit reached -2.25% drift before complete loss of stiffness occurred and the actuator supported end dropped. The wires of the mesh were heard snapping one after another as this occurred. The unit would have landed on the floor at the actuator end but was caught by dunnage placed under the unit near the actuator to avoid this. It was caught at -4.25% drift which is shown in Figure 21. The residual negative moment crack after returning to 0% drift is displayed in Figure 22.

Figure 21: East (Left) and West Side of Specimen 4 (Right) at -4.25% Drift

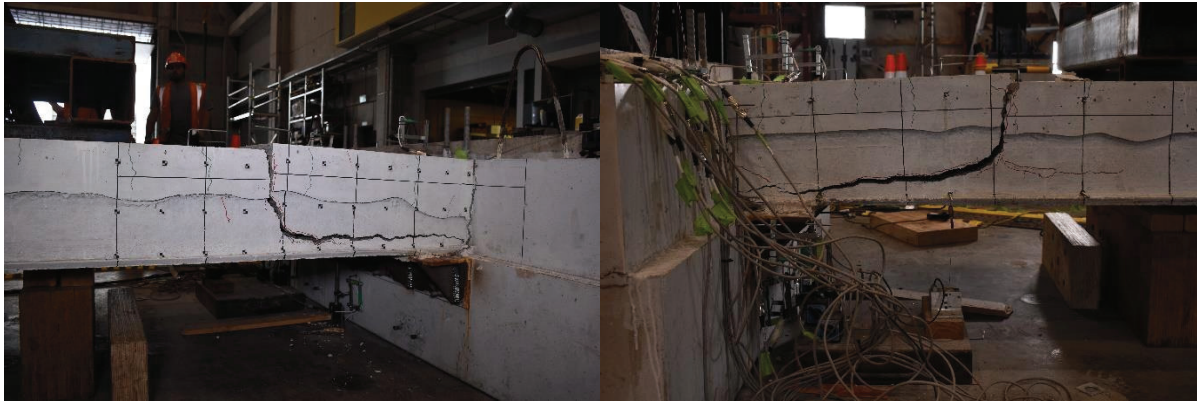
Figure 22: East Side of Specimen (Left) and West Side of Specimen (Right), the Residual Crack at 0% Drift

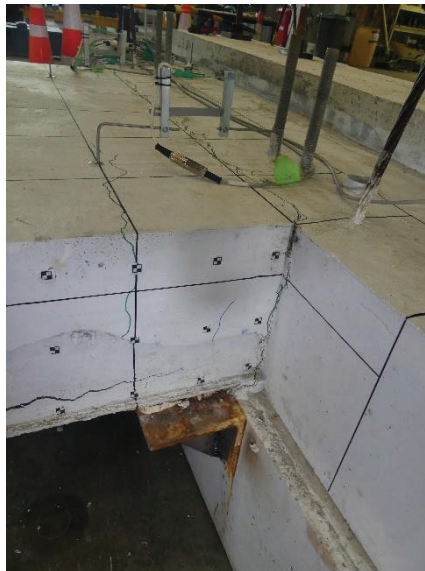
The negative moment crack was observed to have propagated down to the bottom of the unit near the end of the angle as shown in Figure 23. This meant the unit was mainly being held up by the prestress strands acting in dowel action.

Figure 23: Full Depth Crack Propagation at Collapse

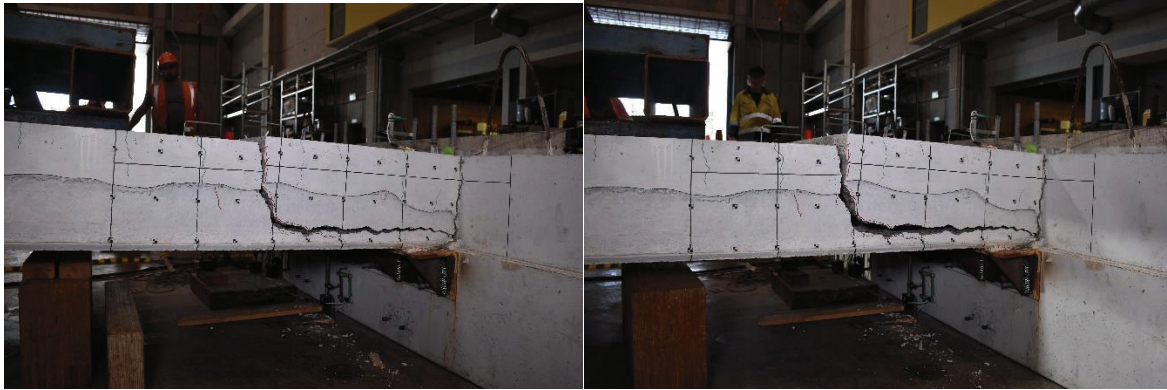
The unit was taken to positive 4.0% drift. Note in Figure 24 how the bottom section which contains the prestress strands pried up the top section which contains the starter bars. After the complete loss of stiffness in the negative portion of the 3.0% drift cycle, these had become two separate sections.

Figure 24: Positive 4.0% drift (Left) and Residual (Right) Showing Prying Effect of Separated Sections

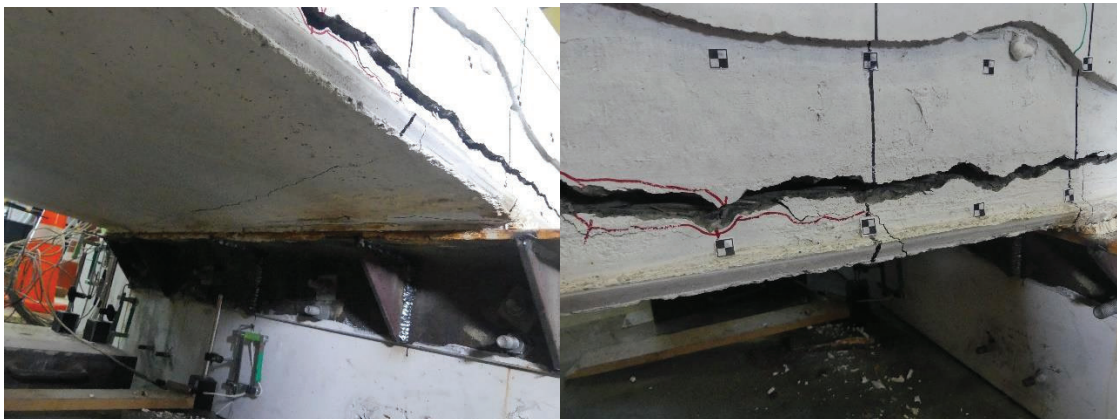
During the positive 4.0% drift cycle it was found that the crack at the soffit widened and new full depth cracks developed in the region of the thin section containing the prestressing strands just beyond the ledge as shown in Figure 25. The prestress strands also became fully visible at the top of the reduced support section. Note that from previous drift cycles, it was found that no new damage occurred in the positive drift cycles. It is expected that other than the new soffit cracks in the reduced support section, no significant new damage occurred in this cycle. The prying of the top starter bar section simply made the damage from the negative portion of the cycle more visible.

Figure 25: Extensive Soffit Cracking at +4.0% drift

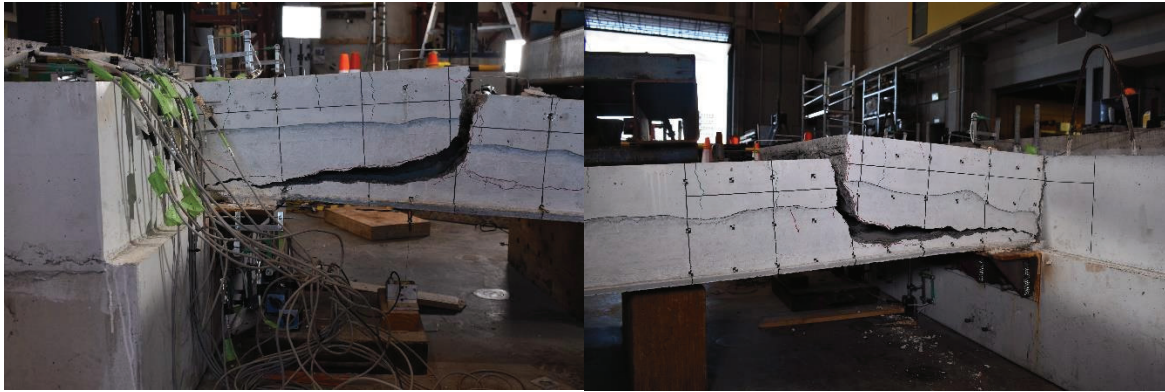
The unit was then taken to -6.0% drift where the test was finished. The unit provided no stiffness throughout the displacement, instead acting like a pin around the ledge support as shown in Figure 26. The snapped mesh from the complete loss of stiffness at -2.25% drift was clearly visible as displayed in Figure 27.

Figure 26: Unit Connection at -6.0% drift – End of Test

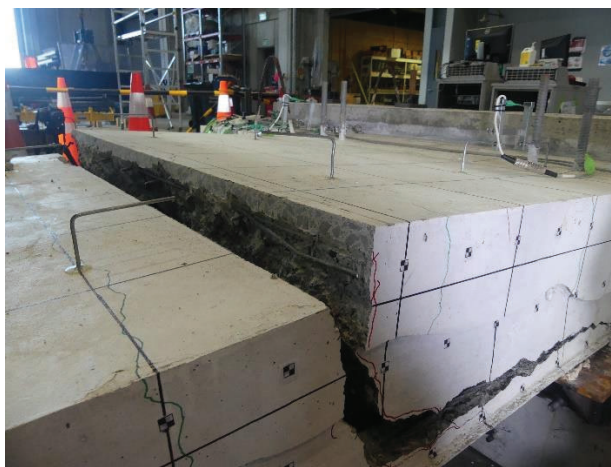
Figure 27: Snapped Mesh visible at Test End

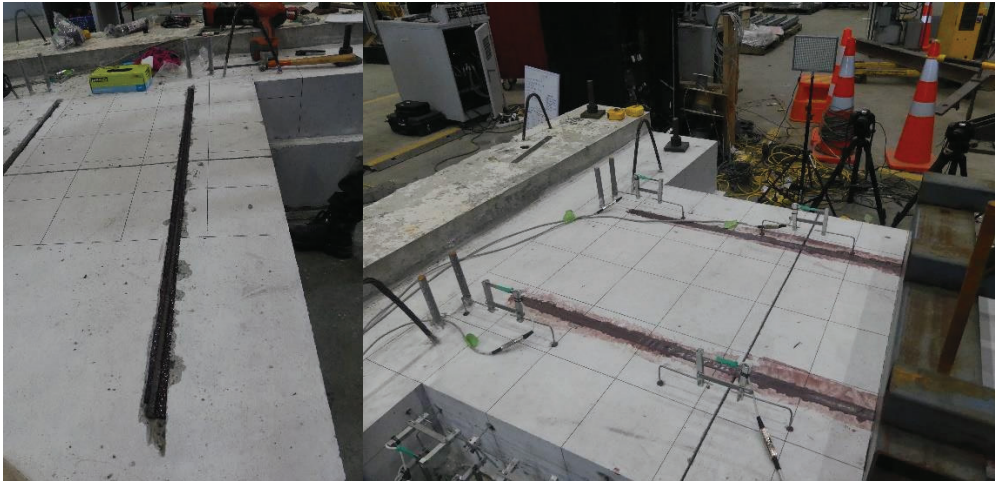
Figure 28: Post-Installed Bar Retrofit Before (Left) and After (Right) Filling Channels with Epoxy

Specimen 5 was used to test a potential retrofit strategy to prevent the NMF triggered in Test 4. This retrofit was the post-installation of two 1.4 m long HD12 bars into the topping, starting from the back face of the unit. Two 30 mm deep and wide channels were cut into the unit topping. The retrofit bars were then placed within the channels and cast in using epoxy. Note, it is important for this retrofit that the post-installed bars do not cross the interface between the unit back face and the support beam front face. This is because this would increase the demand that the starter bars at the unit back face could impose at the end of the starter bars – negating the positive effects of the retrofit. This configuration is outlined in Table 1 and the retrofit strut-tie solution is shown in Figure 5. The retrofit at different stages of installation is displayed in Figure 28.

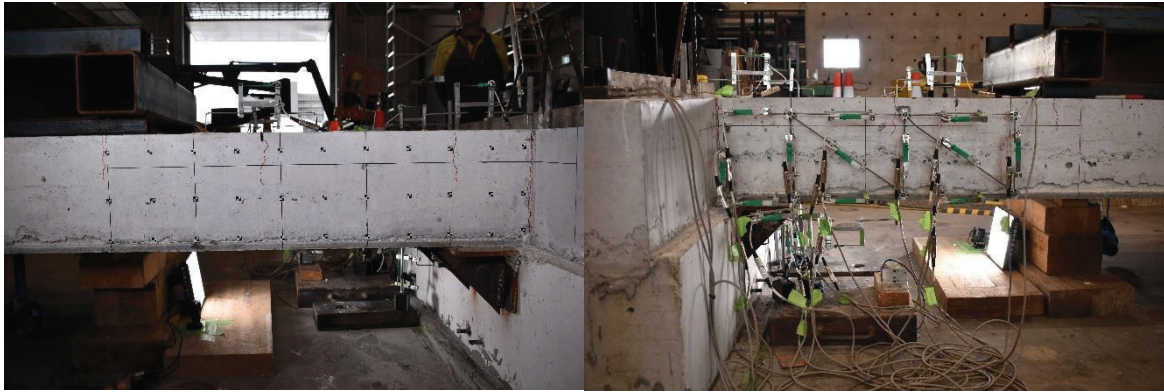
No damage was visible until -0.25% drift. At this stage the back face of the unit cracked, and the sudden loss of stiffness instantly dropped the unit to -0.4% drift. The back-face crack was only hairline at this stage. When load was next applied to move to -0.5% drift, cracking developed in three locations on both the east and west sides as shown in Figure with a fourth developing at -0.75% drift as shown in Figure .

Figure 29: Specimen 5 at -0.5% Drift (West – Left, East – Right)

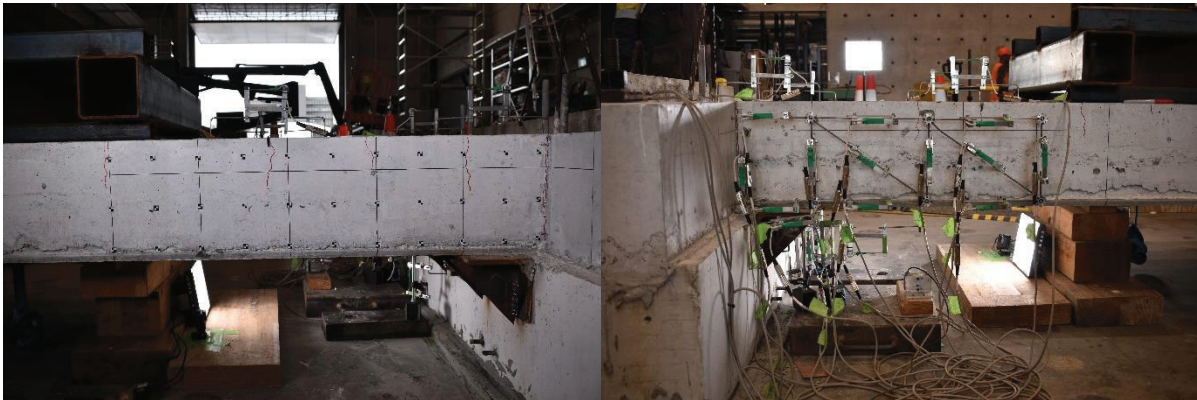
Figure 30: Specimen 5 at -0.75% Drift (West – Left, East – Right)

The quick progression of the cracks away from the back face of the unit at low drifts displayed the large impact of the stiff angle providing greater restraint. It also showed the engagement of the retrofit bars as they underwent stress and held together the formed cracks by distributing the strain along their length. As the drift increased, more distributed cracks formed, and the existing cracks propagated further into the unit. The cracks did not propagate further than half way through the hollowcore unit depth as shown in Figure 29 and Figure 30.

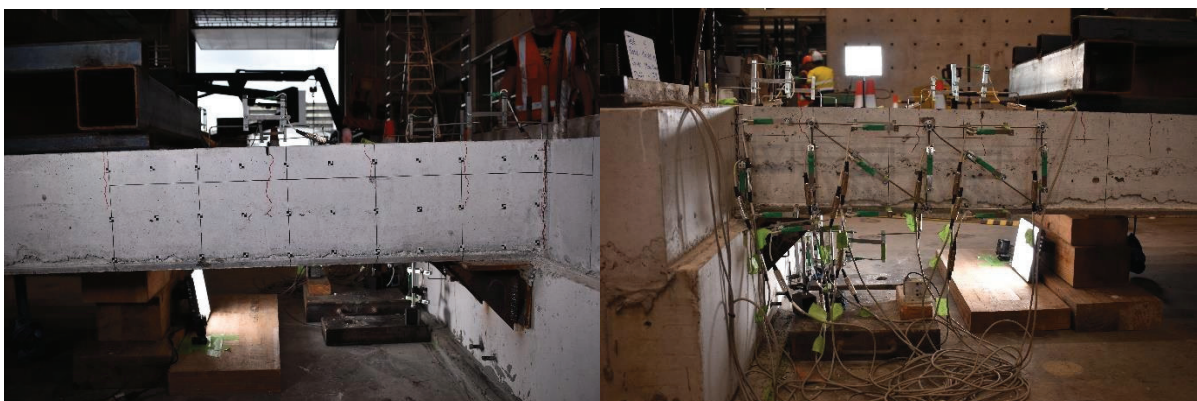
Figure 29: Specimen 5 at -2.0% Drift (West – Left, East – Right)

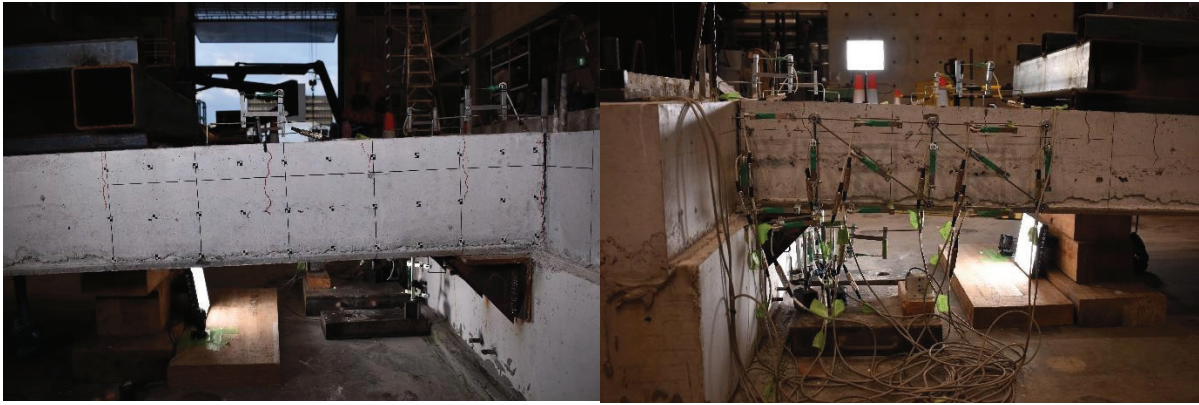
The retrofit performed well and prevented negative moment failure up to the monotonic limit of -3.5% drift. Many cracks formed in the topping and progressed into the unit, but none went beyond half the depth of the unit. Instead, they propagated a short way for 0.25-0.75% drift then stopped after another section cracked. This repeated as the retrofit bars became engaged over more of their length until there were crack lines across the full width of the unit at regular intervals of approximately 200-250 mm as shown in Figure 29 and Figure 30. On reaching approximately -2.25% drift, most of the damage stopped in the unit and concentrated at the back face instead (noting that this was the same drift that the un-retrofitted case had complete loss of stiffness – this may be a coincidence). A difference from previous tests was that whenever loading was stopped, the load reading would relax to the same load every time - approximating to an equivalent 50 kNm at the end of the starter bars. The unit would spring up slightly, no matter how far the starter bars had been pushed past yield and into strain hardening (Test 3 had NMF crack initiation at the end of the starters at around 54 kNm). Near the end of the monotonic displacement of the test, the unit was springing back up by approximately 2.5 mm at the actuator end, within 10 seconds of stopping loading. The retrofit bars appeared to be acting like springs attached to the top of the unit, and at the end of each push the distributed cracks would close as the retrofit "spring" bars recovered some of the tension strain, without increasing tension load being applied. The more cracks that were distributed along the unit, the more spring-back was observed. Overall, the top of the unit in the first 1-1.4 m from the back face behaved much more similarly to a beam in the plastic hinge zone than Specimen 4, which only had mesh reinforcing and had a non-ductile negative moment failure mode. The distributed cracking in the topping can be seen in Figure 31.

Figure 30: Specimen 5 at -3.5% Drift (West – Left, East – Right)

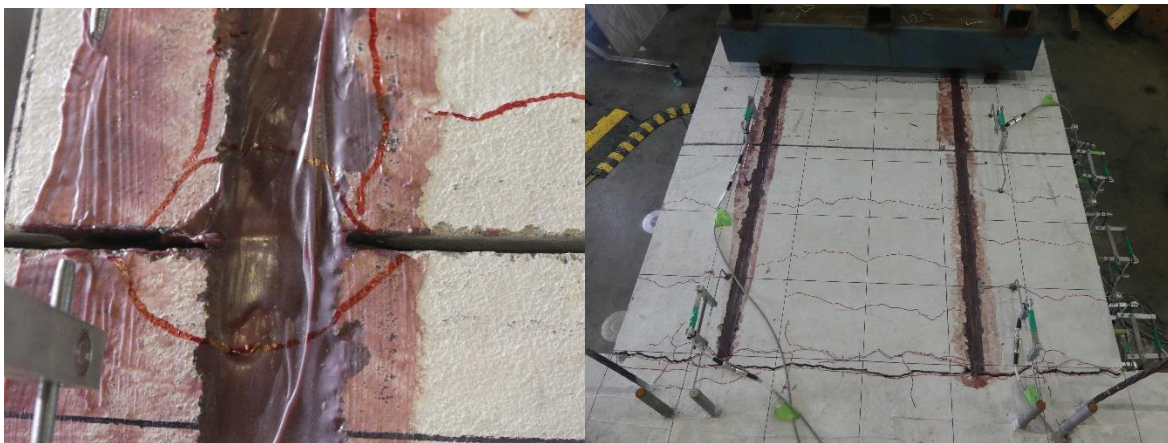
At -4.5% drift, some cracks developed in the epoxy over the NMF sawcut crack initiator. This is shown in Figure 31.

Figure 31: Specimen 5 Cracking in Epoxy (Left) and Distributed Topping Cracking (Right) at -4.5% Drift

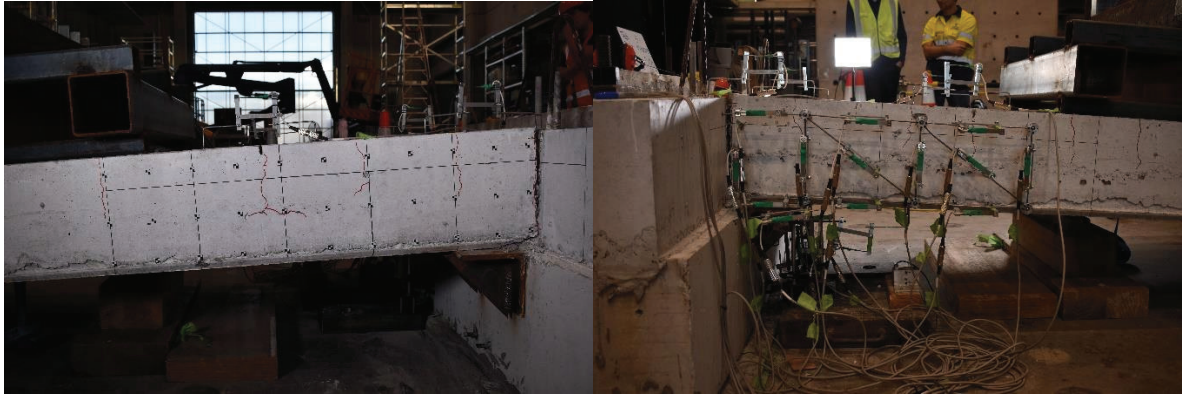
The NMF saw cut crack propagated a short way horizontally on both sides, but it was at the mid-height of the unit, in contrast to Test 4 where it propagated right down to the prestressing strands. The critical NMF saw cut crack was 0.1 mm wide at the top at this stage. Other cracks propagated down a short way into the unit as well. Some minute cracks were possibly observed to be running longitudinally along the epoxy but were so faint it was hard to observe or determine if they were cracks. The test ended at -6.0% with no additional NMF saw cut crack propagation. The NMF saw cut crack opened to 0.3 mm at the top at this stage. The specimen at -6.0% drift is displayed in Figure .

Figure 34: Specimen 5 at -6.0% Drift (West – Left, East – Right)

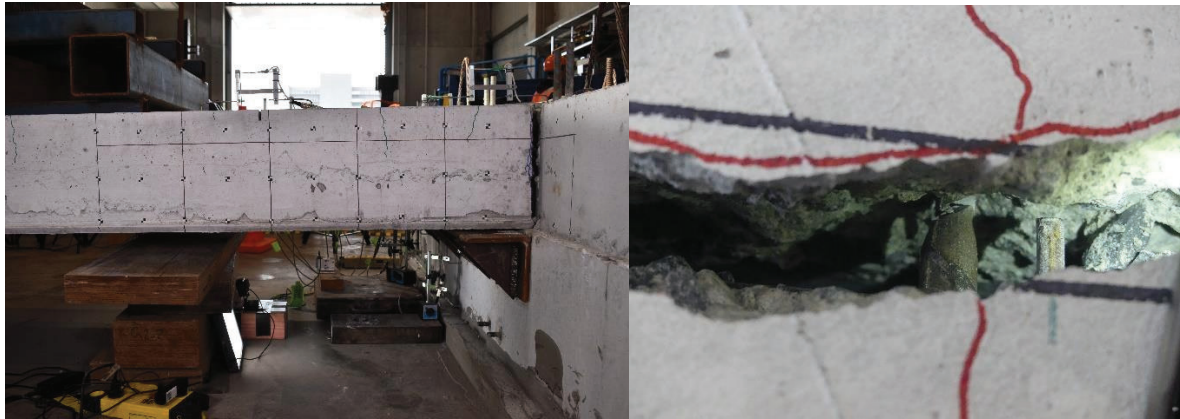
Initial cracking of the unit occurred as a full depth hairline crack at the back face of the unit in the first 0.5% drift cycle. Damage remained concentrated at this crack for the rest of the test. No further interesting damage occurred until the second 2.0% drift cycle. As the unit reached -2.0% drift, the middle starter bar ruptured. This is shown in Figure .

Figure 35: Specimen 6 at -2.0% Drift (Left) and Ruptured Middle Starter Bar (Right)

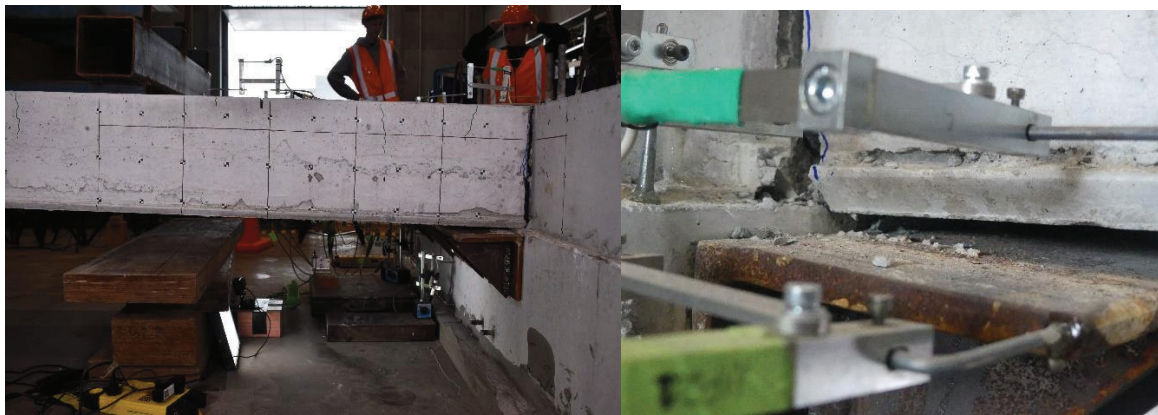
After the first bar ruptured, restraint of the unit and reaction was greatly reduced. In a real building, this would have the effect of reducing the diaphragm effect provided by the floor. In the first 3.0% drift cycle, the unit began dropping off the ledge support on the eastern side during the first +3.0% cycle as shown in Figure 36. The outer starter bar on the eastern side of the specimen also ruptured as the unit was approaching -3.0% drift.

Figure 36 Specimen 6 at +3.0% Drift (West – Left) and LOS on Eastern Side at +3.0% Drift

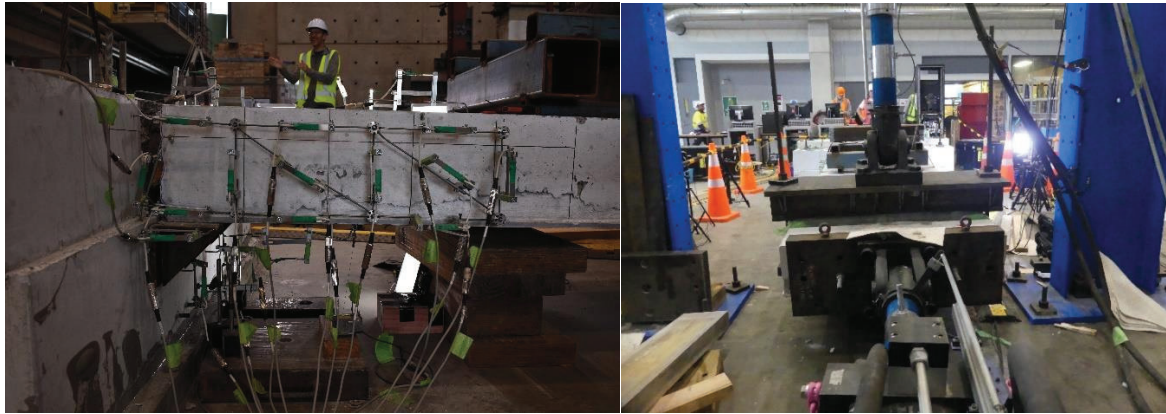
The restraint and reaction of the unit was dropping even further after the rupture, suggesting necking and imminent rupture of the final (western) starter bar. However, only having one remaining point of connection between the hollowcore unit and beam section (that was off-centre in plan) changed the structural system of the experiment. As tensile load was applied the unit began to twist in plan around the last remaining starter bar as shown in Figure . This could be considered a limitation of a single unit test. In a real building the unit would have been restrained from twisting in plan by adjacent units or beams. This would have likely caused the final two starter bars to rupture at similar drifts.

Figure 37: Specimen 6 - Out of Plane Twisting of Unit After Rupture of Two Starter Bars (-3.0% Drift)

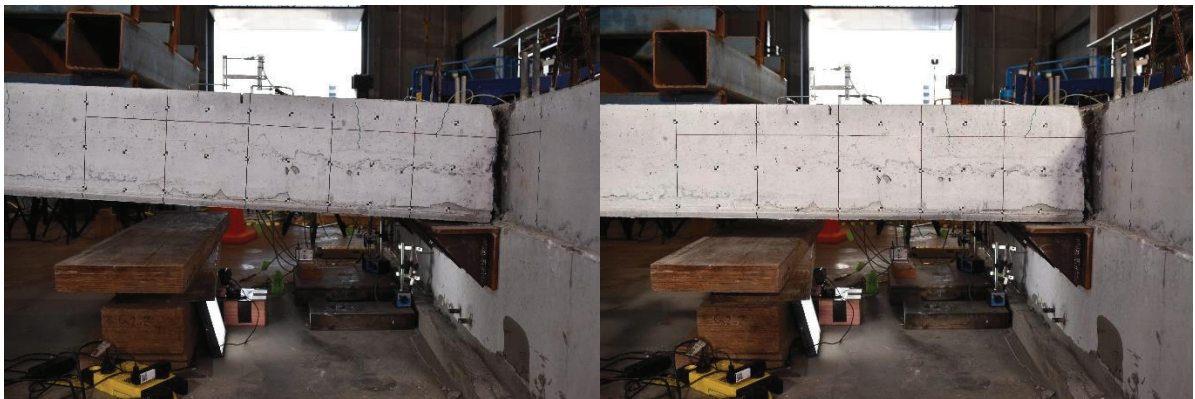
To allow the completion of the test up to a cycle at 4.5% drift with complete LOS of the unit, the final starter bar was manually cut after both 3.0% drift cycles were complete. The 4.5% drift cycle was completed with the unit completely supported by the angle. There was no indication of restraint against the beam ledge or cracking occurring away from the support as shown in Figure .

Figure 38: Specimen 6 – Full LOS at +4.5% Drift (Left) and Residual Displacement (Right)

- Lowering the seating angle retrofit 10 mm under the unit soffit is a valid retrofit strategy, as it removes the effect of this retrofit detail promoting NMF and instead acts as a catch-frame for the falling floor. Under the test conditions, there was no indication of an issue with the unit landing on the angle once LOS occurred. However, it is recommended for new angle installations that a lowered seating angle with a compressible material infill between the angle and unit soffit is used. This would provide minimal restraint to the unit but also ensure that no impact loading occurs during an earthquake where vertical accelerations could be substantial.
