**Report For NZ EQC On The Effects Of Tsunamis In NZ**

**THE EFFECTS OF TSUNAMIS  
IN NEW ZEALAND**

**REPORT ON  
THE EFFECTS OF TSUNAMIS  
IN NEW ZEALAND**

STRUCTURAL DESIGN  
Technical Services : Civil Engineering  
Works and Development Services Corporation (NZ) Ltd  
P.O. Box 12-003, Wellington  
New Zealand

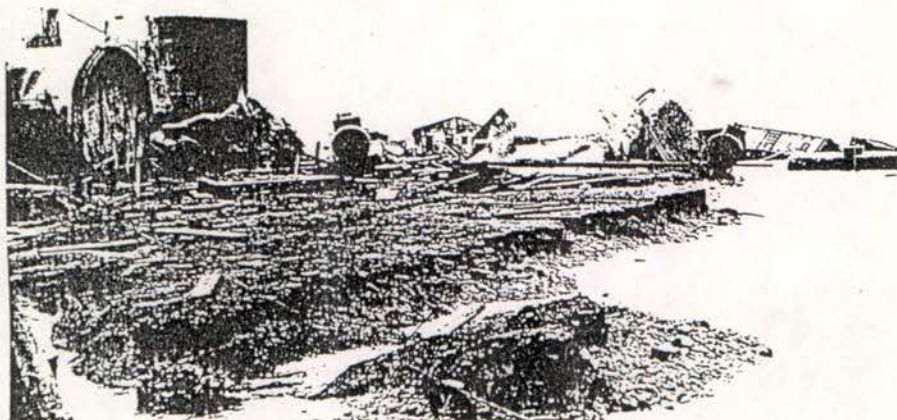
Figure 11-7. Texaco oil tanks after the 1964 tsunami and fire at Seward, Alaska.

bay. Large fractures broke the ground surface behind the slide area and extended several hundred feet inland as shaking continued. Some fractures near the Texaco tanks reportedly opened and closed repeatedly during the shaking; some were at least 20 feet deep. They filled quickly with water and, as the shaking continued, spewed muddy water at intervals. . . [Figure 11-7].

one by the tsunami. Figures 11-7 through 11-11 show the tsunami damage and the head of submarine landslide. However, based on the author's personal inspections, building damage in the city due only to ground vibration was minimal to moderate, and these inspections included non-earthquake-resistive masonry buildings.

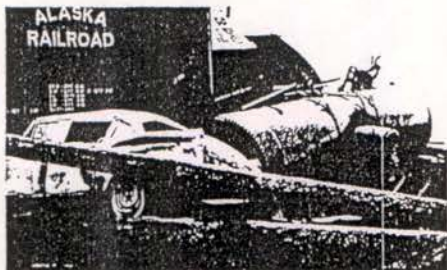
Figure 11-11. Detail of tsunami damage shown in Figure 11-10.

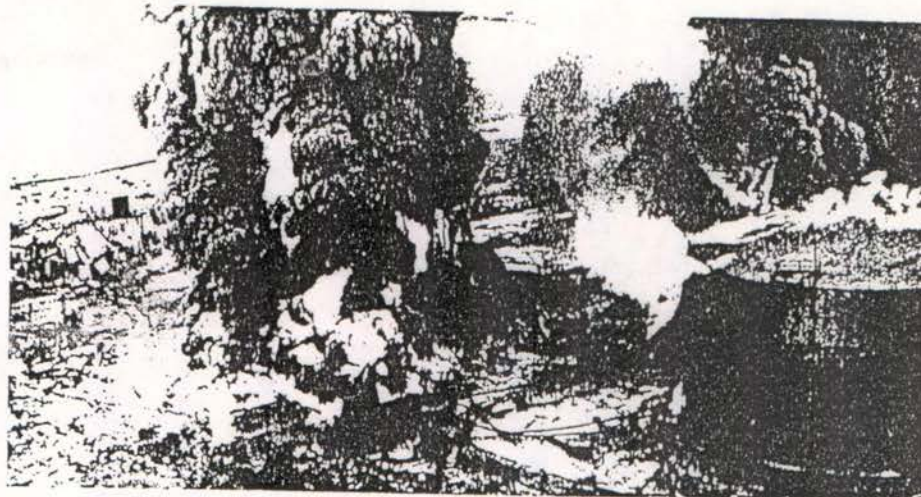
Figure 11-13. Union Oil tanks on fire at Whittier, Alaska, after the 1964 earthquake and tsunami.

Whittier also experienced submarine landslides and tsunamis which destroyed docks, oil facilities, and rail facilities (Figures 11-12 and 11-13). Wave runup was highest on the north shore of Passage Canal where it reached a height of 104 feet. Twelve lives were lost. The nearby 14-story building was not subject to tsunami forces; the ground vibration caused only minimal to moderate structural damage (Figure 11-14).

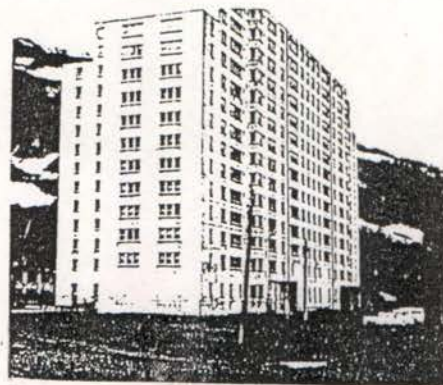
Figure 11-14. Hodge Building at Whittier, Alaska, after the 1964 earthquake. Building suffered between minimal and moderate structural damage.
