Vicki Moon & Willem de Lange
School of Science
University of Waikato

1. Introduction

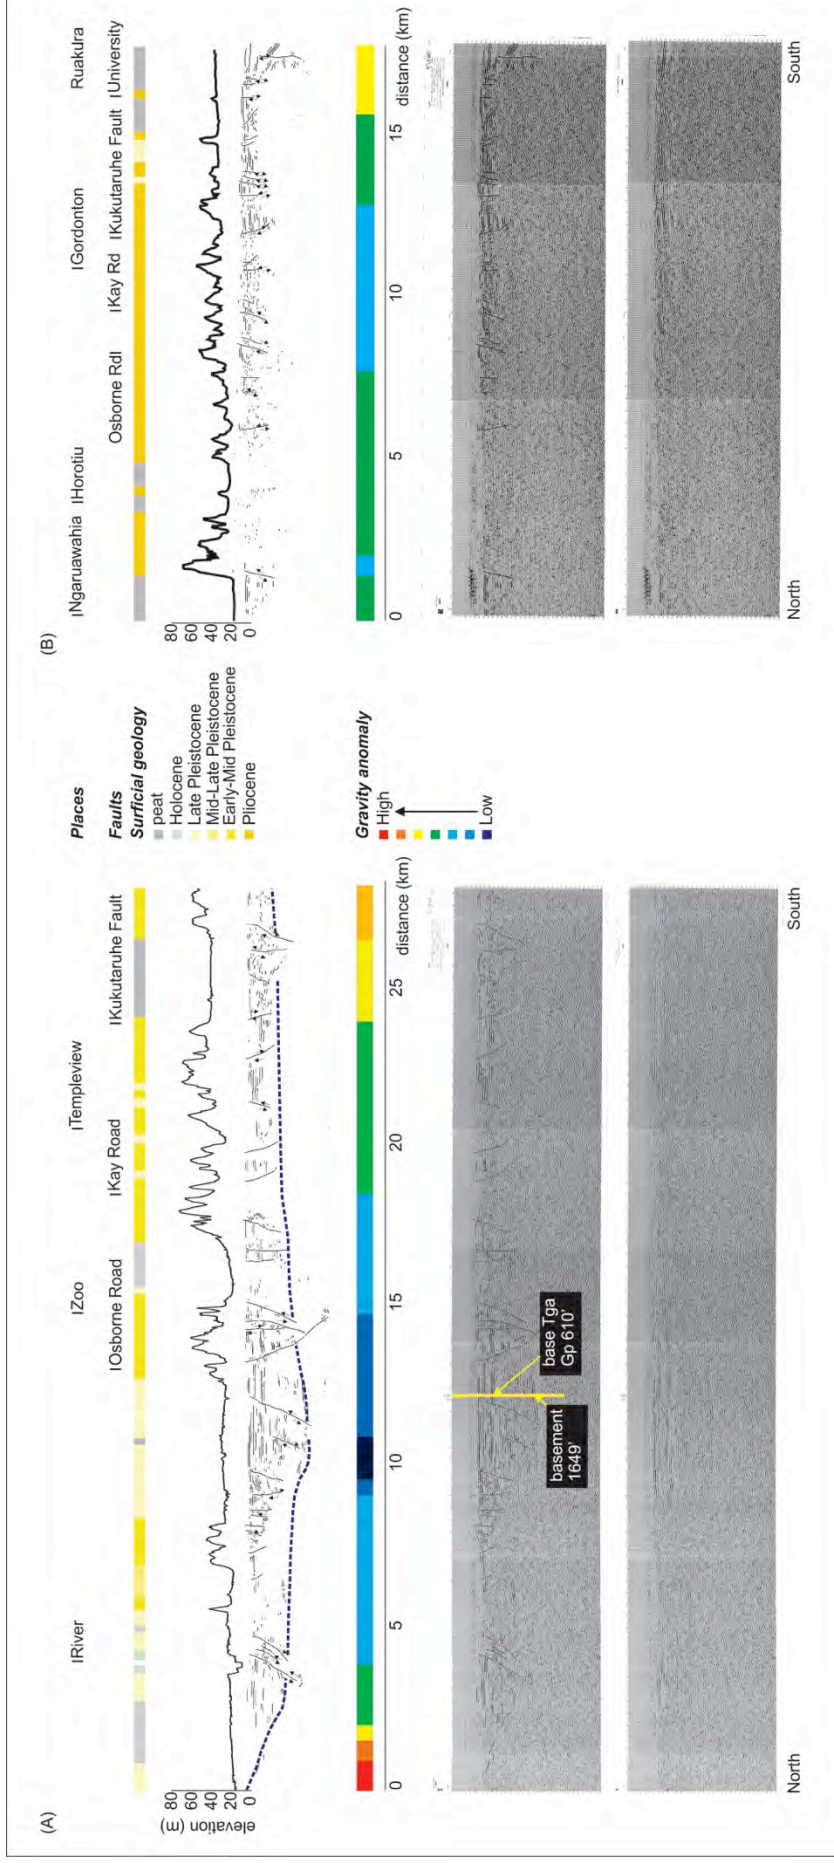
Figure 10. Interpretation of seismic reflection lines from PR569 (Liles, 1971). (A) Line PR569-2 running along the western margin of Hamilton City. (B) Line PR569-16 running to the east of Hamilton City. Original and interpreted images are shown at the base of the diagrams, with key stratigraphic horizons identified from borehole Te Rapa-1 (Liles, 1971) marked on (A). Indicative gravity anomaly strips are shown, with colours derived from FrOG Tech (2011). Interpreted sections, including depth to basement for (A) marked with a dashed blue line are overlain with geomorphology (vertical exaggeration ~ 30x), and surficial geology is marked with a coloured strip. Fault traces identified on land are indicated, and several geographic locations are projected onto the line and marked for reference.

The basement surface mapped in PR569-2 indicates a steep dip in the north on moving away from the Hakarimata Range, falling to a maximum under northern Hamilton, then rising at a gentle slope ($\sim 3^\circ$) towards the south. This agrees with the gravity anomaly presented by FrOG Tech (2011) as indicated in coloured strip in Figure 10A. As the seismic reflection data is very poor below the greywacke upper surface, it is unclear whether or not the faults continue into the basement, but we assume that they do.

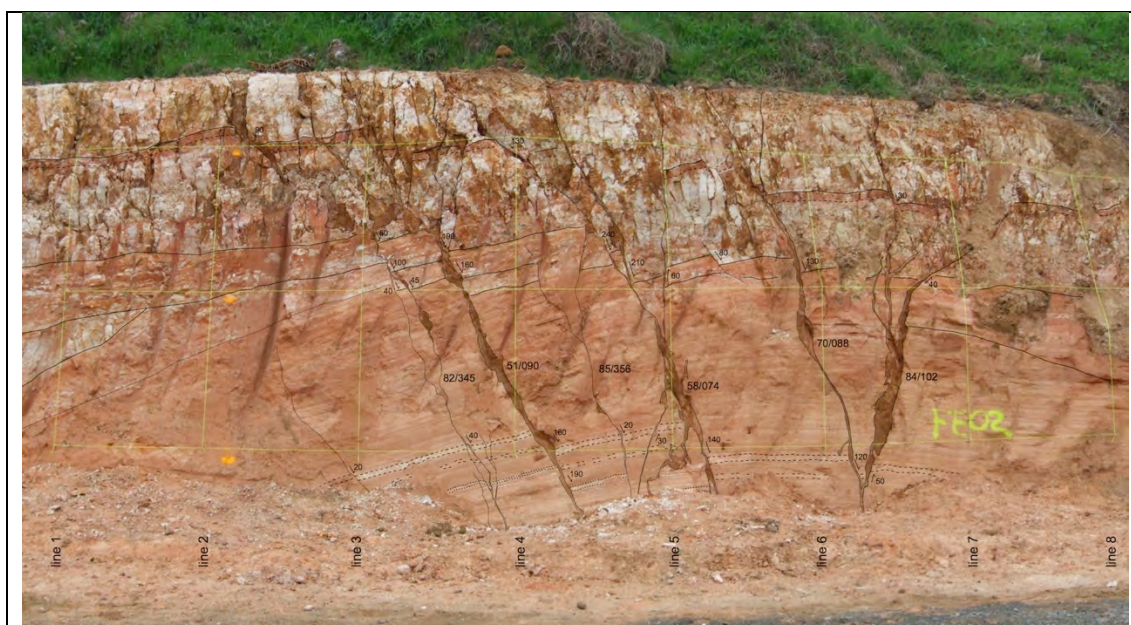
Figure 17. Exposed face within an excavation at Rototuna showing faults within the Kukutaruhe Fault Zone.

The site initially identified at Rototuna (37°43'24" S, 175°16'40" E) is a fault zone exposed in the wall of an excavation (Figure 17). The zone is approximately 4 m wide, comprising 4 main strands of the fault trace, with several smaller strands linking between them, and has a total vertical offset across the zone of approximately 0.5 m. Normal (extensional) movement occurs across this zone, with dips on the strands ranging from 51 – 84°. The 4 apparent main strands have an average dip direction of 089° (strike 356°), while the 2 measurable minor strands have a dip direction of 351° (strike 081°).

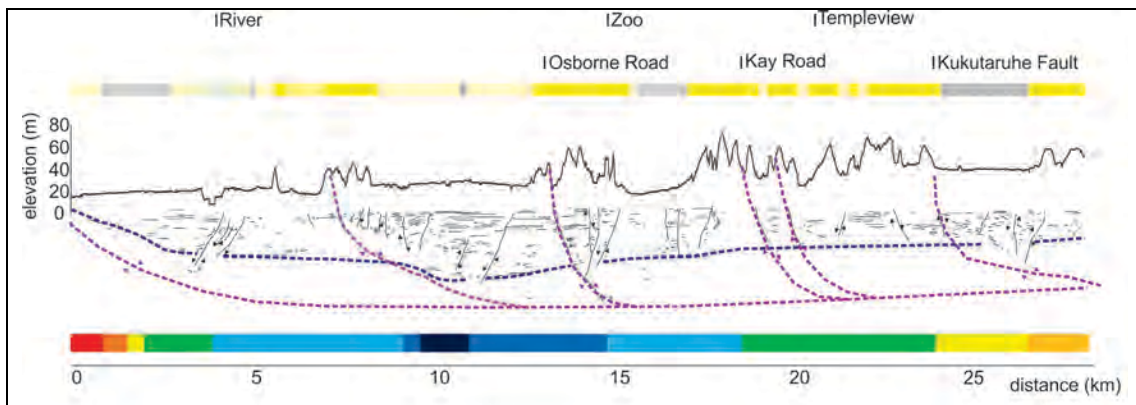
Figure 32. Interpreted seismic section of Line PR569-2 (Liles, 1971) as shown in Figure 10 with inferred listric faults included in magenta. The depth to which these extend in the basement is unknown, so the depth shown here is purely schematic.

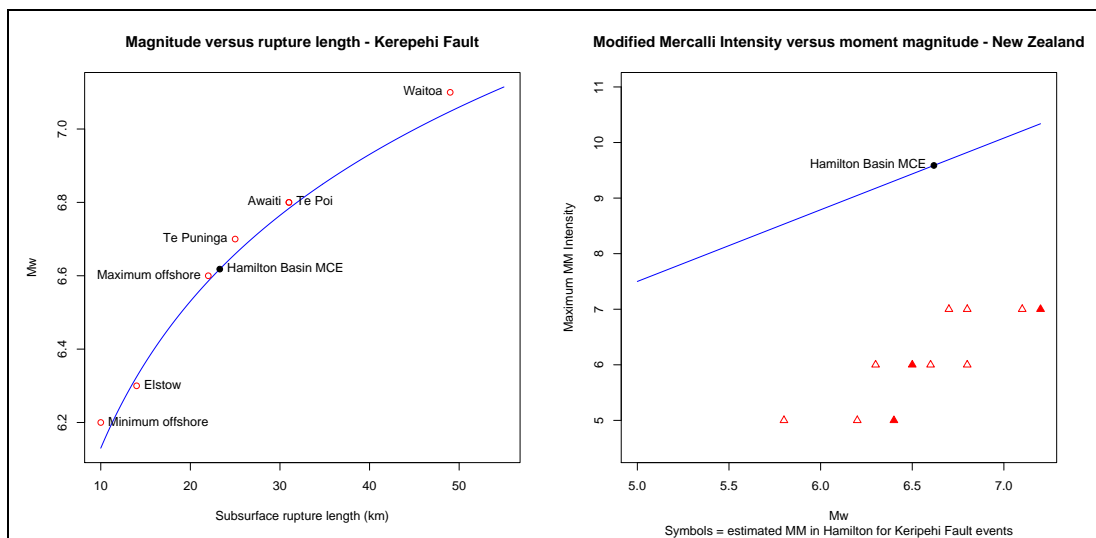
Figure 34. Calculated maximum magnitude (left) and Modified Mercalli Intensity (right) for the largest fault rupture length in Figure 31, and those predicted for Hamilton City for rupture of the Kerepehi Fault segments by Persaud *et al* (2016).

Assuming that the methodology used by Persaud et al (2016) for the Kerepehi Fault segments is also applicable to the faults within the Hamilton Basin, it is possible to estimate the maximum credible earthquake (MCE) associated with the fault segments in Figure 31. Figure 34 compares the MCE for a ~25 km fault rupture within the Hamilton Basin with the predicted values for Hamilton City based on different rupture scenarios for the Kerepehi Fault. The MCE magnitude corresponds to Mw 6.6, with a maximum MM Intensity of 9-10. These data suggest that the shaking intensity within Hamilton City will be significantly greater due to a local earthquake than predicted for the Kerepehi Fault. Research is now focussing on obtaining data to determine the frequency of rupture within the Hamilton Basin. This includes a student project undertaking a review of historical records and oral histories of local iwi, which has so far identified several damaging events during the 1800s.
