**FINAL REPORT ON EQC RESEARCH  
CONTRACT 10/SP607:  
‘A QUANTITATIVE ANALYSIS OF  
VOLCANIC ASH DAMAGE TO NEW  
ZEALAND ROOF STRUCTURES AND  
MATERIALS’**

**20 July 2011**

### **TECHNICAL ABSTRACT**

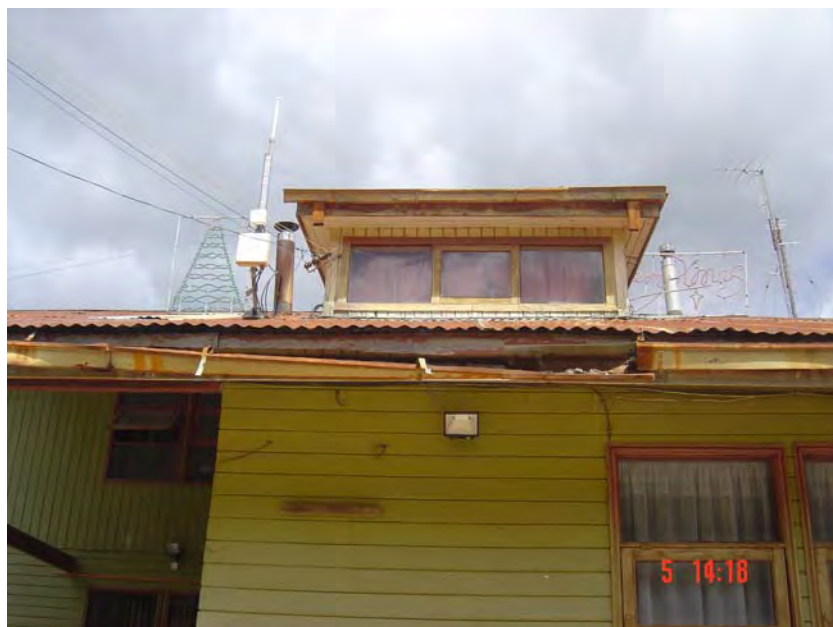
**Fig 1:** Corrosion to roof cladding and gutter collapse following 200 mm of ashfall in Futaleufu, Chile following the 2008 Chaiten eruption (Photo: T. Wilson).

The 23/01/09 – 12/02/09 volcanic impact reconnaissance trip to areas in Chile and Argentina impacted by heavy ashfalls following the 2008 Chaitén eruption (partially supported by EQC) was directed by David Middleton (EQC) to undertake analysis of ashfall impacts to residential buildings. Residential houses of similar construction to New Zealand (mostly corrugated galvanised iron roofs), in a similar climatic setting, were exposed to a range of ashfall impacts, with many suffering corrosion to metallic cladding on the roof. Where ash depths were >50 mm gutters were damaged or collapsed due to ash washing from the roof and causing overloading (Fig 1). A survey of residential buildings in Futaleufu, Chile, following 200 mm of ashfall has shown that extensive damage has occurred to the building inventory there, without structural failure of the roof occurring. This damage includes significant and rapid corrosion of corrugated sheet steel roof cladding and corrosion, infilling and collapse of rain gutters and down pipes. Our analysis of damage sustained in Futaleufú, Chile as a result of the May 2008 eruption Chaitén volcano, Chile shows that over 72% of the roofs were estimated to be damaged (corrosion) in the observed building stock. This is similar to damage reported by Deguchi (1988) in Kagoshima (~55%) and Tarumizu, Japan (~65%) after the 1978 eruption of Sakurajima volcano, one of the few quantified results of roof corrosion damage in the literature. Interviewed residents in Futaleufu stated that damage to their metallic roofs (paint peeling and metal corrosion), gutter damage, and contamination of the house interior was the greatest impact to their personal property and has required municipal aid to assist repairs.

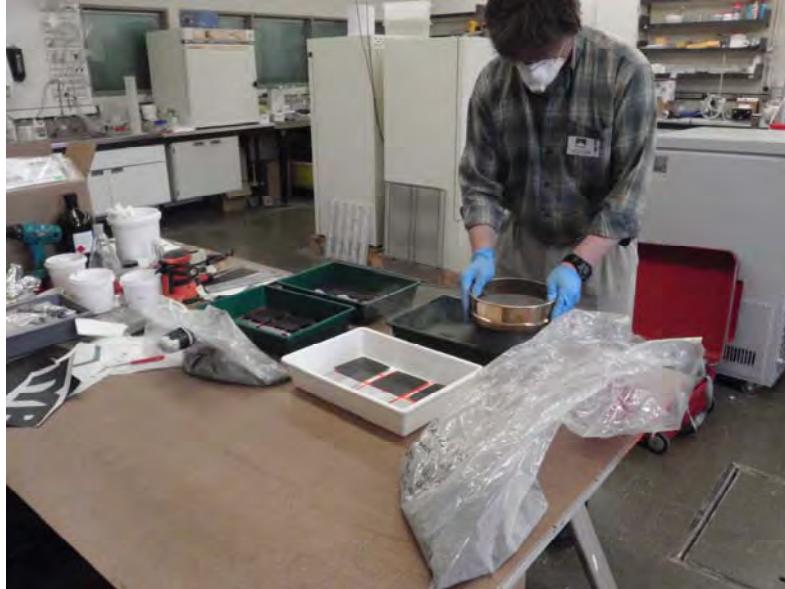
**Fig. 5:** Allan Scott using a sieve to distribute dosed pseudo-ash over samples of roofing material for one-month trial in environmental test chamber (Photo: C. Stewart)

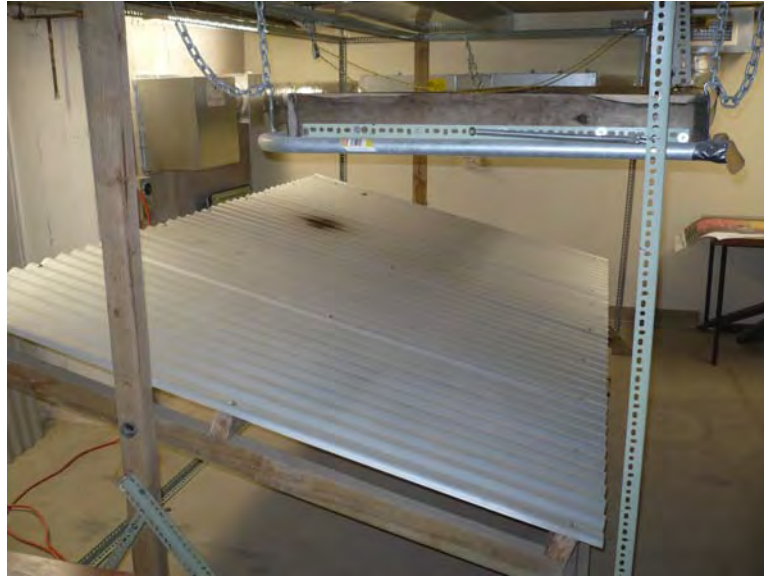
**Fig. 9:** Equipment for roofing and guttering experiments in the VAT facility, University of Canterbury (Photo: G.Wilson)

The Volcanic Ash Testing (VAT) Facility (Fig. 9), housed in the basement of the von Haast building at the University of Canterbury, is part of a multidisciplinary, multi-organization 'VAT Lab' collaboration, which also includes facilities at Massey University, the University of Auckland, US Geological Survey, University College London, as well as the College of Engineering at the University of Canterbury. At this facility, an adjustable frame, capable of holding roofing iron at different angles and different types of guttering, has been constructed to assess the effects of different loadings of volcanic ash. The frame is able to be tilted at 15°, 25°, 35° and 45°, and ash is dispensed from an overlying sieve, which dispenses the ash evenly over the surface in a rocking motion (Fig. 9). Because of time constraints due to the successive earthquakes only preliminary tests using this facility were able to be achieved. Only dry ash and only three tilt angles (15°, 25° and 45°) were used at this stage. Also only one type of gutter (Marley plastic) was used. It is anticipated further tests will be carried out later in the year, prior to submitting a paper on guttering (see section 6.2).

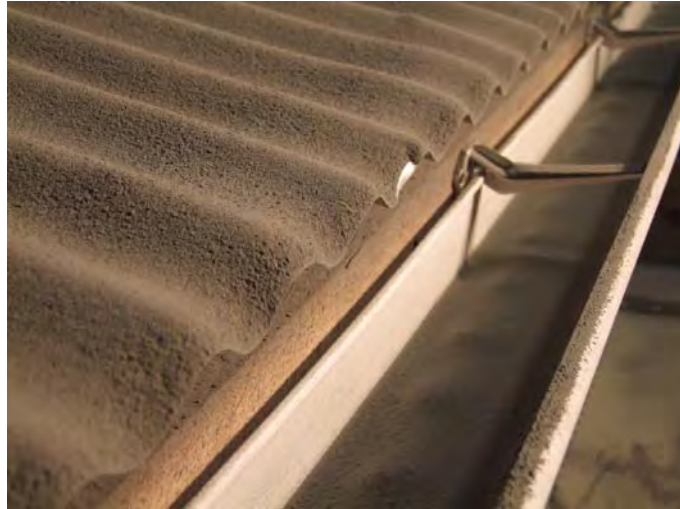
**Fig. 10.** Deposition of ash on roof with  $15^\circ$  angle. The roof surface was mantled with ash, with some infilling the spouting at end of testing (Photo; S. Hampton).

At low angles ( $15^\circ$ ), ash covered both ridges and troughs of the roof, generally with nearly double the thickness of ash in the troughs as on the ridges after ~10mm of ash was deposited in the troughs. Thickness in the gutter was relatively low, with the beginnings of piles forming downslope of the troughs (Fig. 10). Small piles were also deposited across the gutter adjacent to each bracket, and each bracket had a small amount of ash on top. Roof nails became covered by thin ash once ~5mm had accumulated on the ridges.

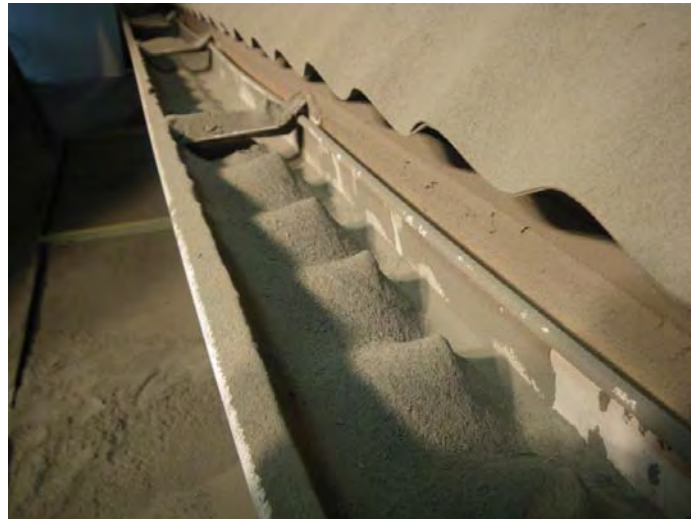
**Fig. 11:** Deposition of ash on a roof tilted at  $25^\circ$ . There is asymmetric ash accumulation in guttering, with piles accumulating beneath troughs. Ash distribution is grain size controlled, with coarse ash depositing on outer edge of spouting. Fine ash accumulates within the gutter until buoyancy caused the ash to bypass the spouting. In distance, ash accumulation is prominent on guttering bracket, limiting ash accumulation beneath.

At intermediate angles ( $25^\circ$ ), the ash starts to move downslope to form an incipient wedge, with more accumulating in the gutter. Ridge: crest ratios were similar to that at  $15^\circ$ , but eventually troughs completely filled (height difference between ridge and trough = 16mm). Piles adjacent to troughs became significant, 2-3 times the height of the surrounding ash (Fig. 11). Ash thicknesses were higher on the outside (front) of the gutter, but some ash stuck on to the inside of the gutter and got into the roof cavity.

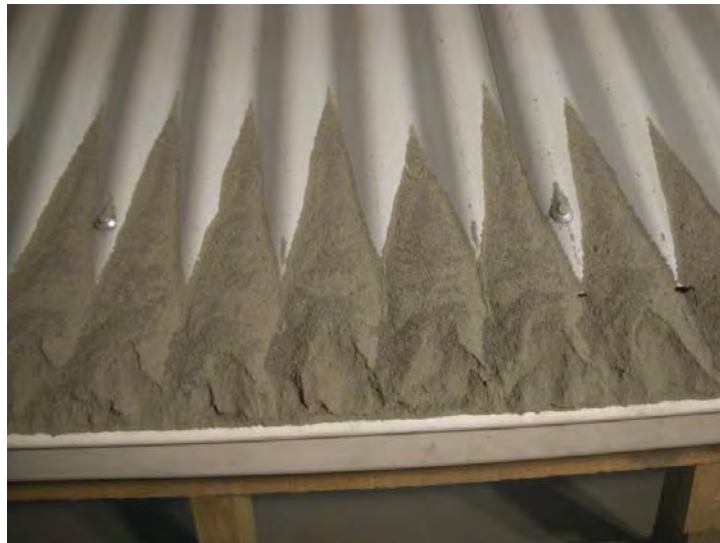
**Fig. 12:** Deposition of ash on a roof tilted at 45°. Talus-like aprons of ash accumulation once spouting is infilled. Position of ash within roof troughs remains static between 200 – 250mm from front edge of roof, with excess ash material shed over front lip of guttering.

At high angles (45°), the ash moved rapidly down the roof troughs and straight into the gutter. This created large piles in the gutter, which grew rapidly until they reached the height of the outer rim of the gutter. At this point fine ash cascaded over the front of the gutter (Fig. 12). Once the gutter became full, ash backed up in the troughs to a distance of 200-250mm, and the fronts of these 'backfills' became unstable and flowed over the front of the gutter to form plumes of fine ash. Once the gutters became full, the central part sagged ~10mm compared to the ends. After about 10mm had collected in the troughs, a small amount of ash accumulated on the ridges, but never more than ~1mm thick. Roof nails trapped the ash during its downwards migration, creating a triangular wedge ~15 mm long and ~4mm high upslope of the nails.
