Appendix B: Forms of Flat Land Damage

Figures B1.2 to B1.3: Photos of land with none-to-minor liquefaction related land damage.

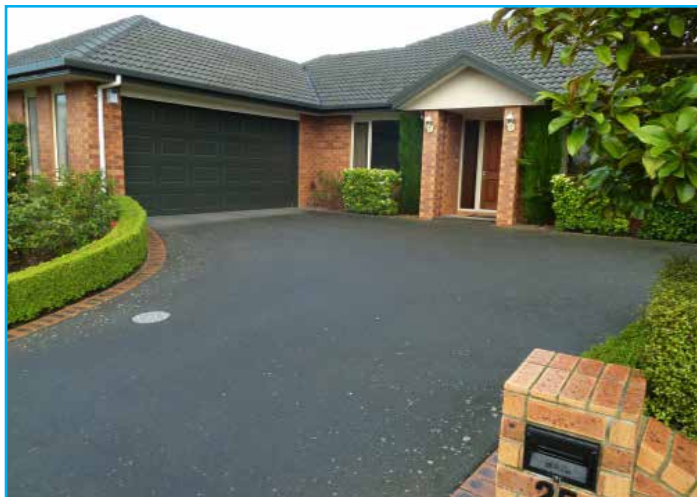
Undamaged asphalt driveway

None to minor land damage

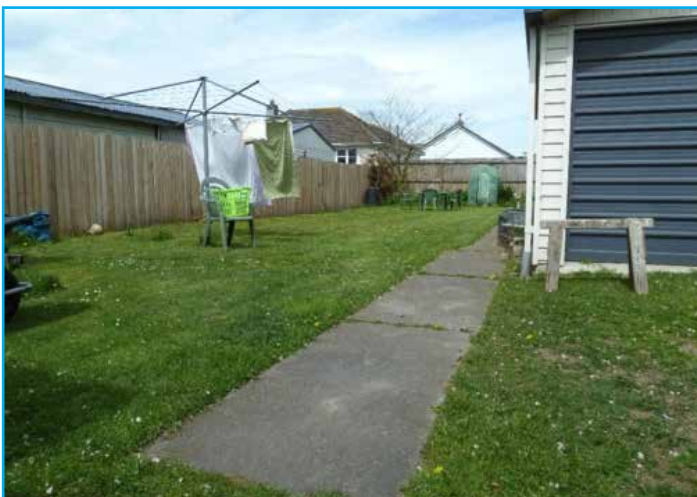
None to minor land damage

Undulating lawn

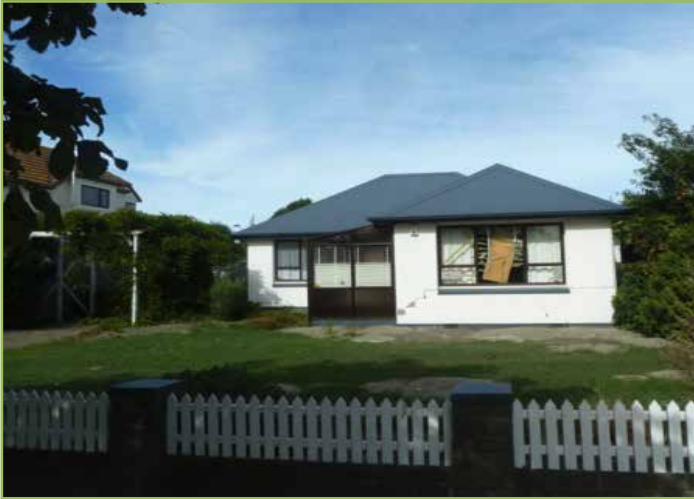
Minor to moderate land damage

Liquefaction ejecta in many areas on lawn

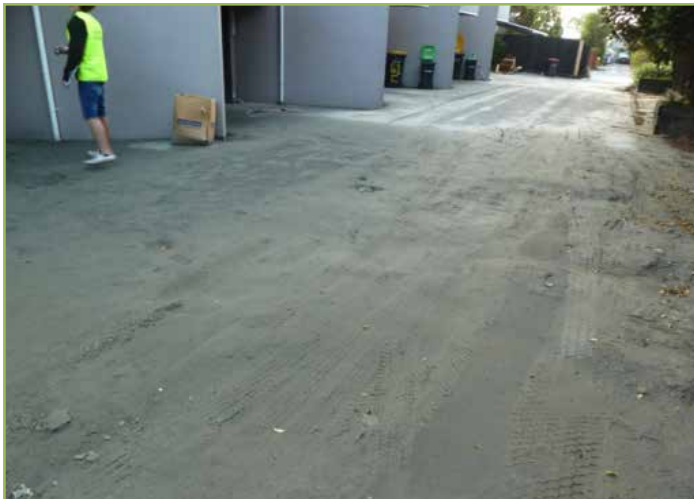
Minor to moderate land damage

Liquefaction ejecta covering driveway

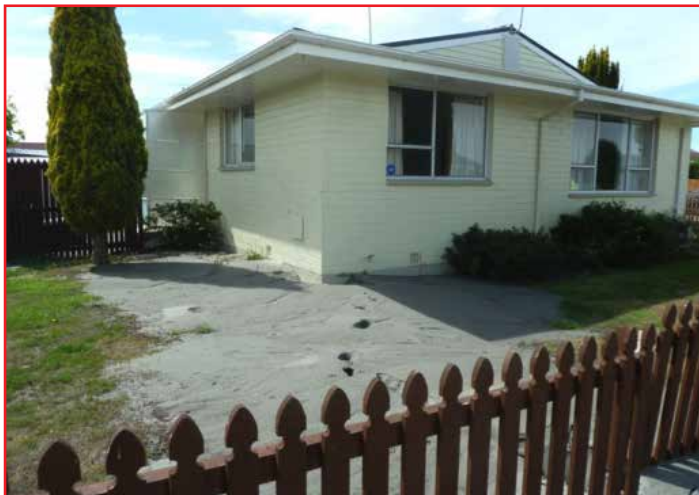
Moderate to severe land damage

Large patch of liquefaction ejecta

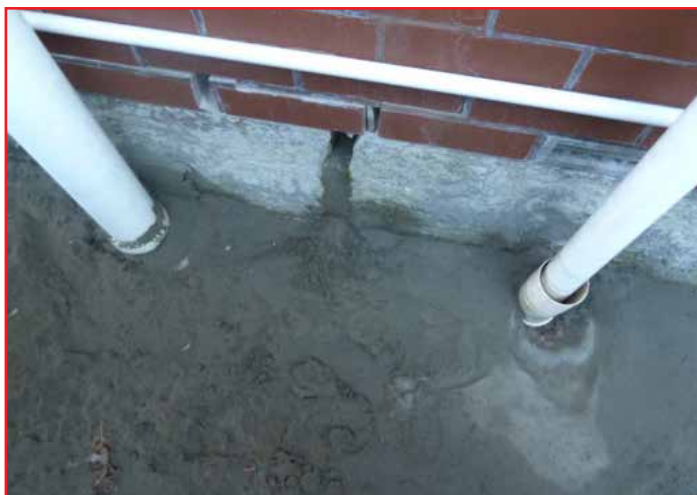
Foundation damage

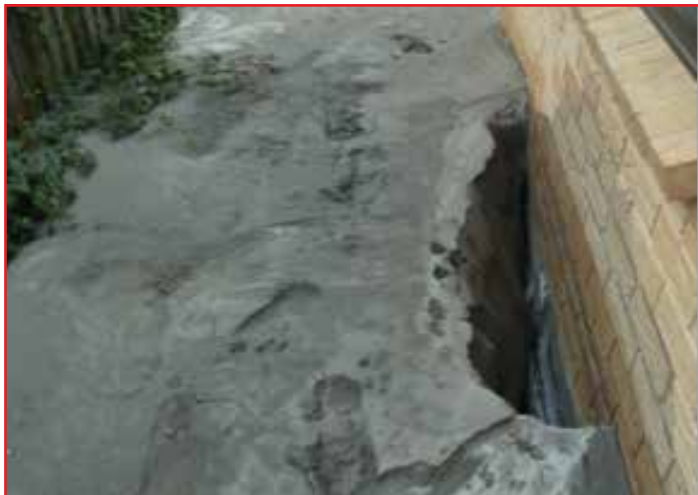
Moderate to severe land damage

Large amounts of liquefaction ejecta

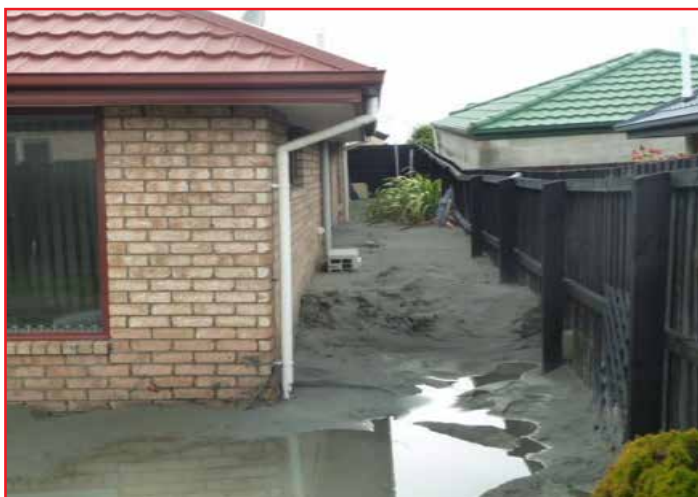
Moderate to severe land damage

Large amounts of liquefaction ejecta

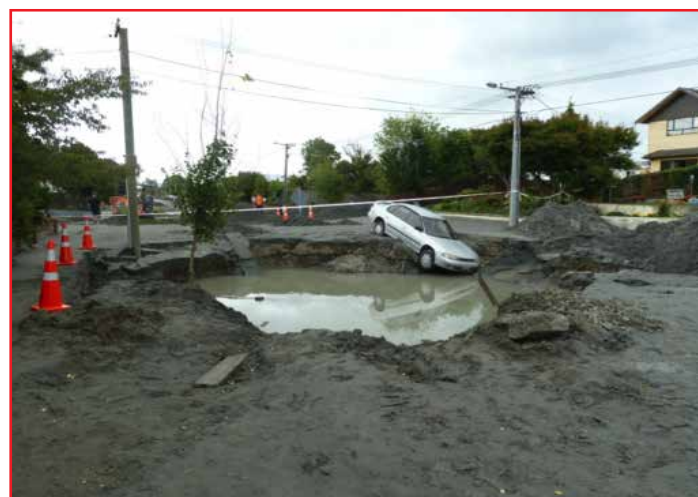
Moderate to severe land damage

Close up photo of road damage seen in aerial photo of Woolston
